June 18, 2012

Re: Windham Mt. Sporting Club
Hydrogeologic Evaluation

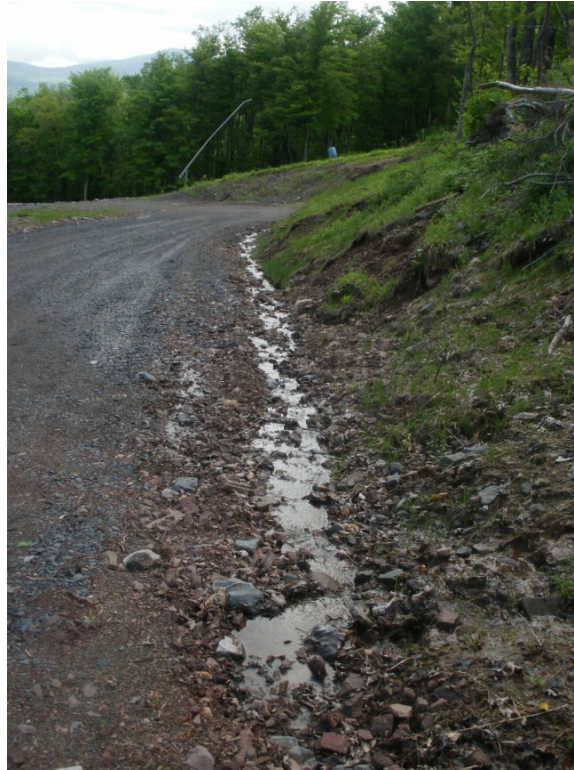
Alpha personnel visited the residential development on the west side of Ski Windham to observe the surface water and interflow patterns associated with that area. That development has been in place for many years and has numerous established road cuts. The development also has some recent and unfinished road construction in the higher elevations (above 2,400 ft elevation) that had cuts into till and bedrock. Minor seepage (interflow) was observed in several of the new road cuts in till and in bedrock along the unfinished road at the uppermost extent of the development. Water from these seeps flowed at approximately one to two gpm in the gravel-lined ditch along the uphill side of the

unfinished road for approximately 200 ft and then re-entered the subsurface (Attachment, Photos 1 and 2).

PHOTO 1: Water flowing in rock lined ditch (1-2 gpm) along unfinished road in the development west of Ski Windham at approximately 2,500 ft elevation.

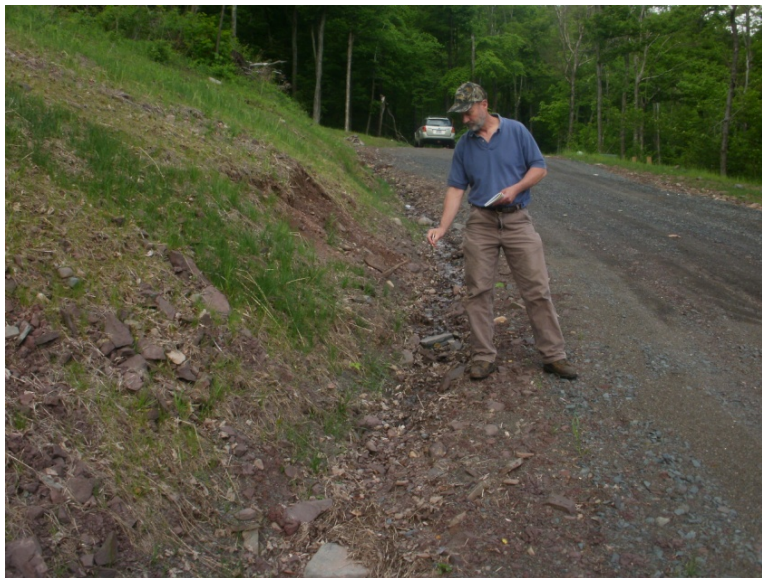
PHOTO 2: All of the flow seen in Photo 1 has infiltrated the subsurface by approximately 200 feet from where the flow originated.

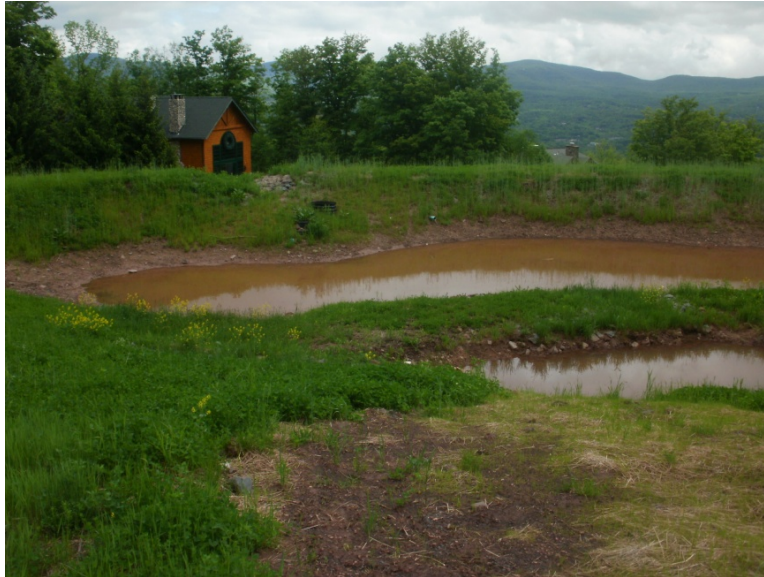
Directly downslope from this location, minor seepage from fissile shale in a rock cut was observed near the top of a chair lift. This is an indication that sufficient seepage and infiltration was present to maintain soil moisture downslope from an existing road cut. Water also reappeared in the same ditch further down the road where the ditch ran directly on the top of bedrock and flowed at approximately one gpm until a portion of it re-entered the subsurface and a portion entered a storm water drainage pipe. A relatively new storm water pond was observed downslope of the unfinished road and at an elevation of approximately 2,360 ft. The water level in the pond was very low and there was no drainage in or out of this pond on May 24, which was less than two days after the recent precipitation events (Attachment, Photo 3).

PHOTO 3: Low water level in retention pond on May 24, 2012, down slope from Photos 1 and 2, with no overflow or discharge two days after 1.5 inches of precipitation.
