**USACOE UPDATED DELINEATION REPORT &
JURISDICTIONAL DETERMINATION REQUEST**

SUBJECT: Permit Application Number NAN-2010-00313-WOR
by Crossroads Ventures, LLC

THE MODIFIED BELLEAYRE RESORT AT CATSKILL PARK, NAN-2000-00748-WETLAND DELINEATION REPORT

Town of Shandaken & Town of Middletown, New York

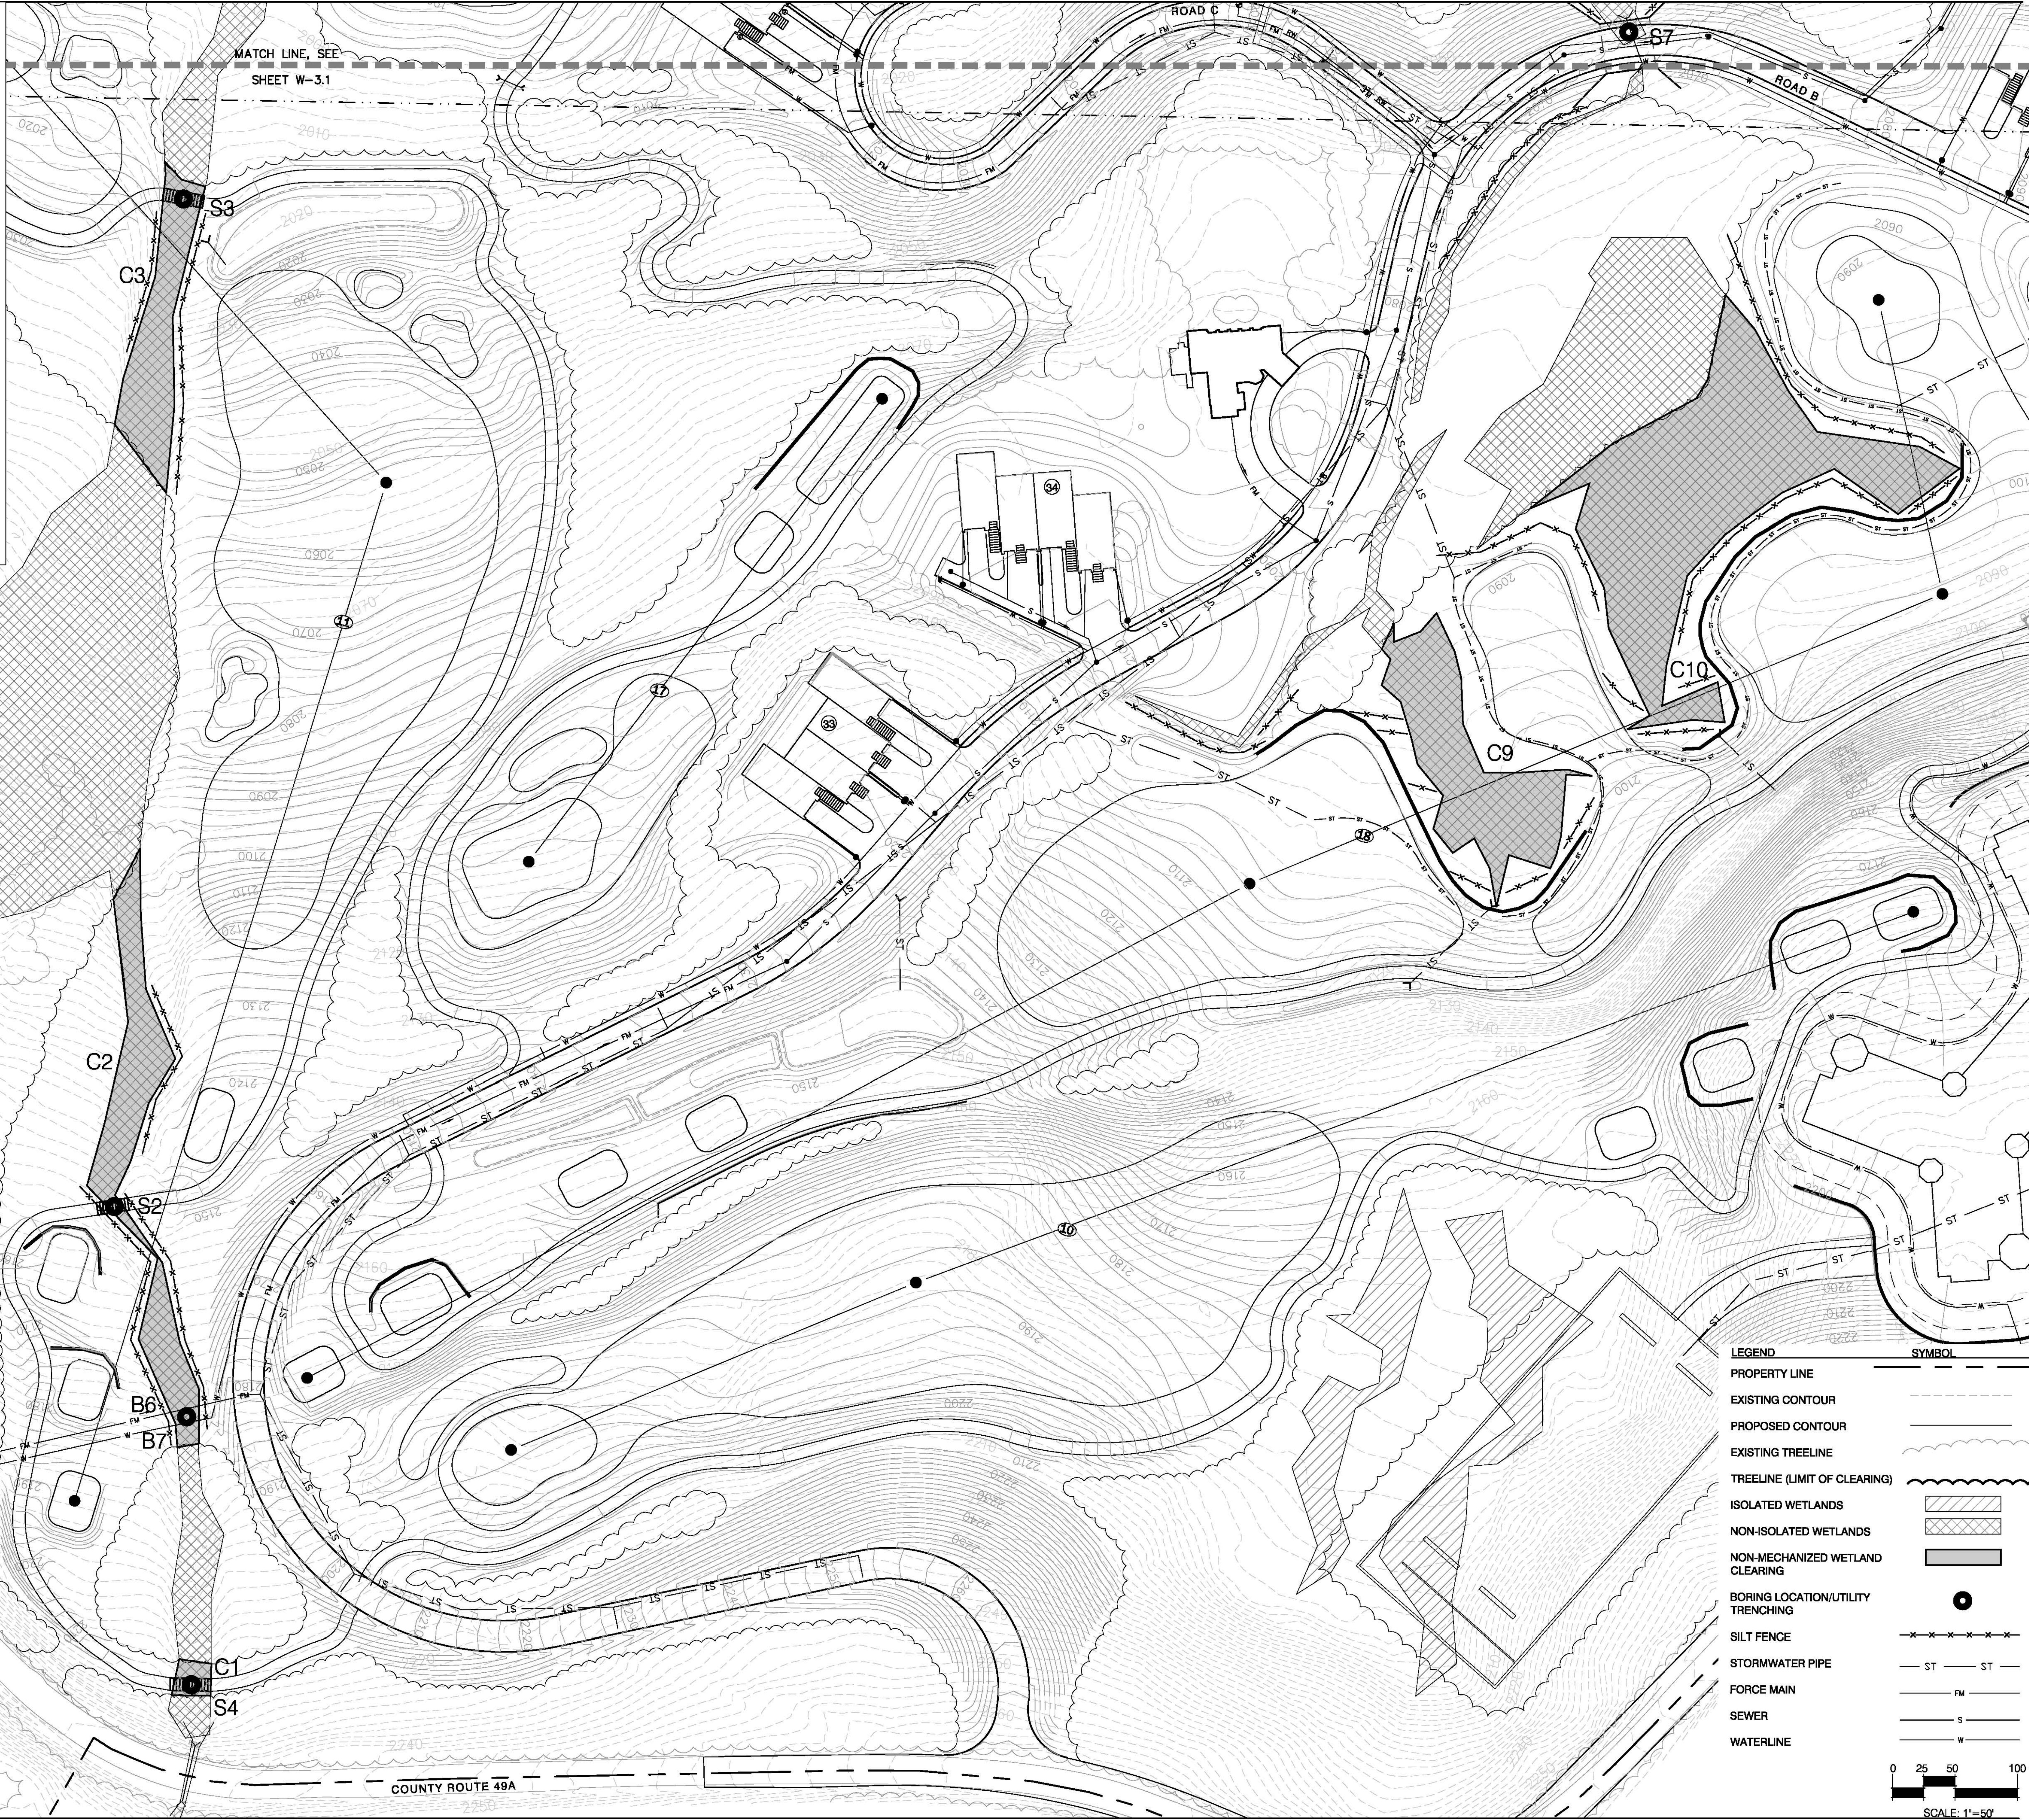
Wetland Areas Crossed by Elevated Golf Cart Boardwalks & Road Bridge					
	Location	Wetland Number	Square feet	(LF)	Acres
S1	Hole 7	24	130	13.0	0.003
S2	Hole 11 - center	16	125	12.5	0.003
S3	Hole 11 - north	16	305	30.0	0.007
S4	Hole 11 - south	16	315	31.5	0.007
S5	Hole 13 cart path	16	360	36.0	0.008
S6	Hole 16 - near tees	21	250	25.0	0.006
S7	Road B Bridge	21	400	24.0	0.009
TOTAL			1,885	172.0	0.043

Wetland Areas Crossed by Subsurface Directional Bore				
	Location	Wetland Number	LF	Acres
B1	Off-Site	-	-	16.5
B2	Off-Site	-	-	16.0
B3	Off-Site	-	-	15.0
B4	Off-Site	-	-	13.0
B5	Off-Site	-	-	22.0
B6	Hole 11 - Tee Box	16	-	20.0
B7	Hole 11 - Tee Box	16	-	20.0
B8	Hole 16 - Tee Box	21	-	25.0
B9	Hole 7 - Tee Box	24	-	11.0
B10	Hole 7 - Tee Box	24	-	11.0
B11	Hole 7 - Tee Box	24	-	11.0
TOTAL				230.5

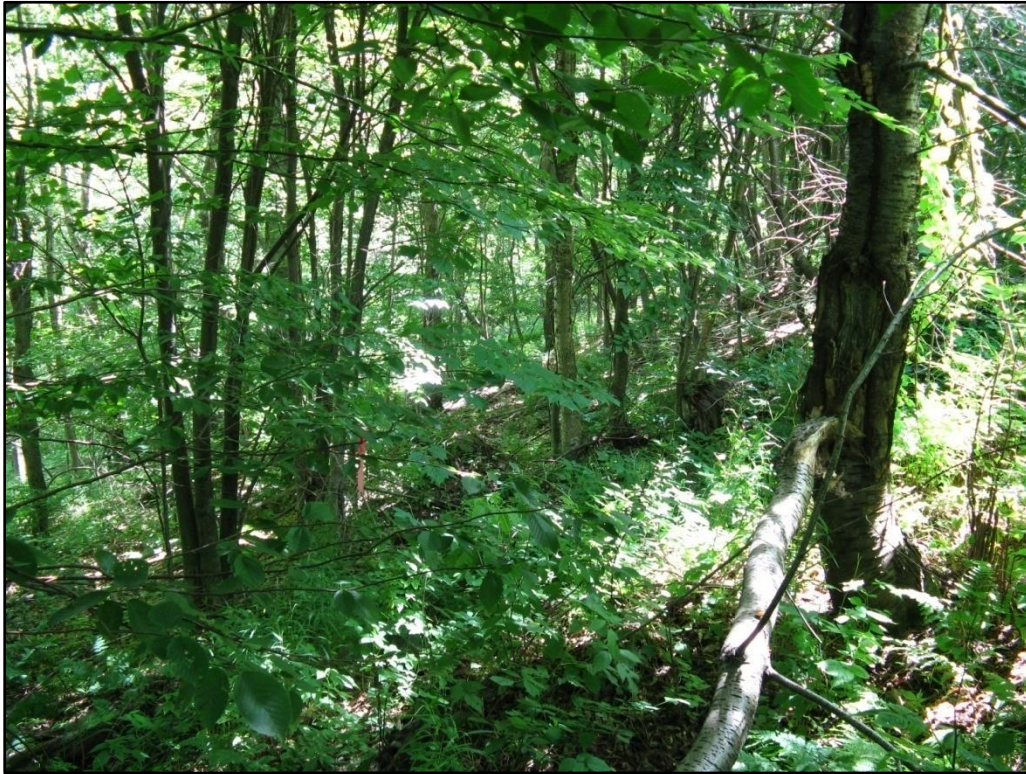
View down the west-facing forested slope near the highest point on the parcel. Dominants in the relatively young forest here are sugar maple, yellow birch, and black cherry. There is also some beech in places and striped maple is common in the understory.

I did not find anything on Parcel D that could be identified as a wetland or watercourse. It appears that all parts of this parcel have enough slope that water runs off and does not collect or get channeled into definite pathways.

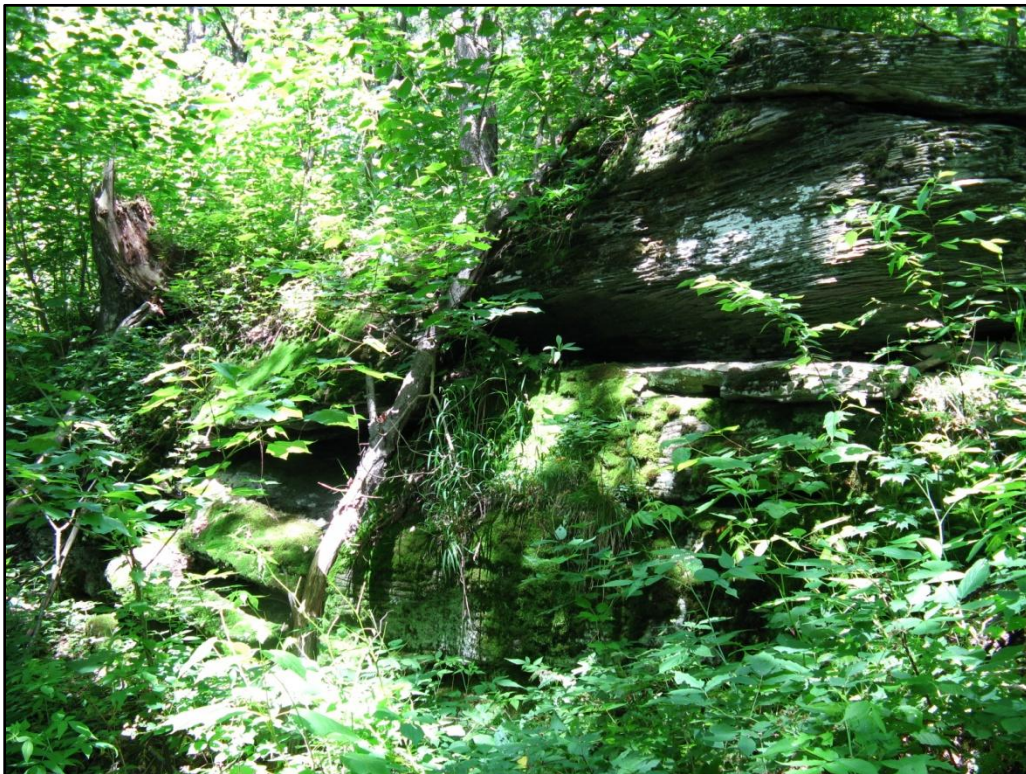
In some places on the slopes of Parcel D, there is exposed bedrock.

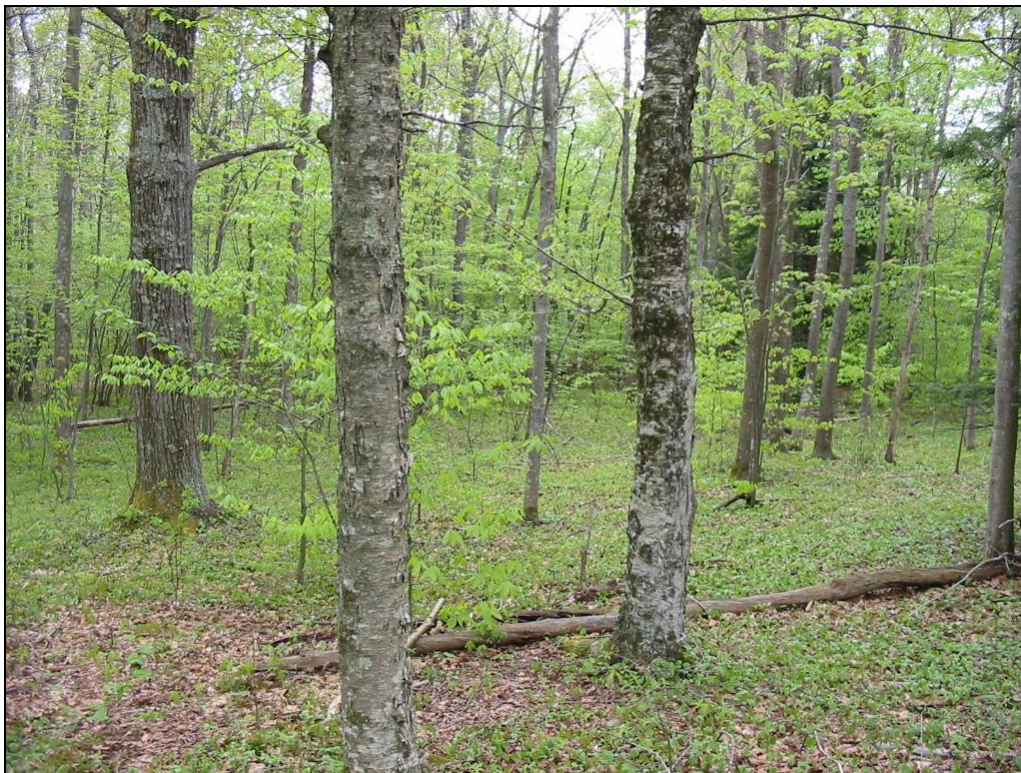
On May 18, 2007, I visited the site known as the “Museum Parcel” on the north side of Route 49A, ca. ¼ mile west of the intersection with NYS Route 28. This site consists largely of a wooded area behind two houses. The woods are relatively mature and are composed mainly of red oak (*Quercus rubra*), beech (*Fagus grandifolia*), yellow birch (*Betula alleghaniensis*), hemlock (*Tsuga canadensis*), sugar maple (*Acer saccharum*), and black cherry (*Prunus serotina*). The ground layer in this forest is typical of the upland mixed deciduous & coniferous forests of the Highmount area, with starflower (*Trientalis borealis*), Canada mayflower (*Maianthemum canadense*), tree clubmoss (*Lycopodium obscurum*), lowbush blueberry (*Vaccinium* sp.), wood anemone (*Anemone quinquefolia*), bracken fern (*Pteridium aquilinum*), and wild sarsaparilla (*Aralia nudicaulis*). Witch-hazel (*Hamamelis virginiana*) is the dominant understory shrub. A photograph showing a typical view of this forest is included below.

I walked the entire site and found it to be covered only with upland forest of this type. I did not see any area within this parcel that would meet the three-parameter definition of wetlands that is used by the federal government. Nor did I see any streams or ponds that would qualify as waters of the United States.

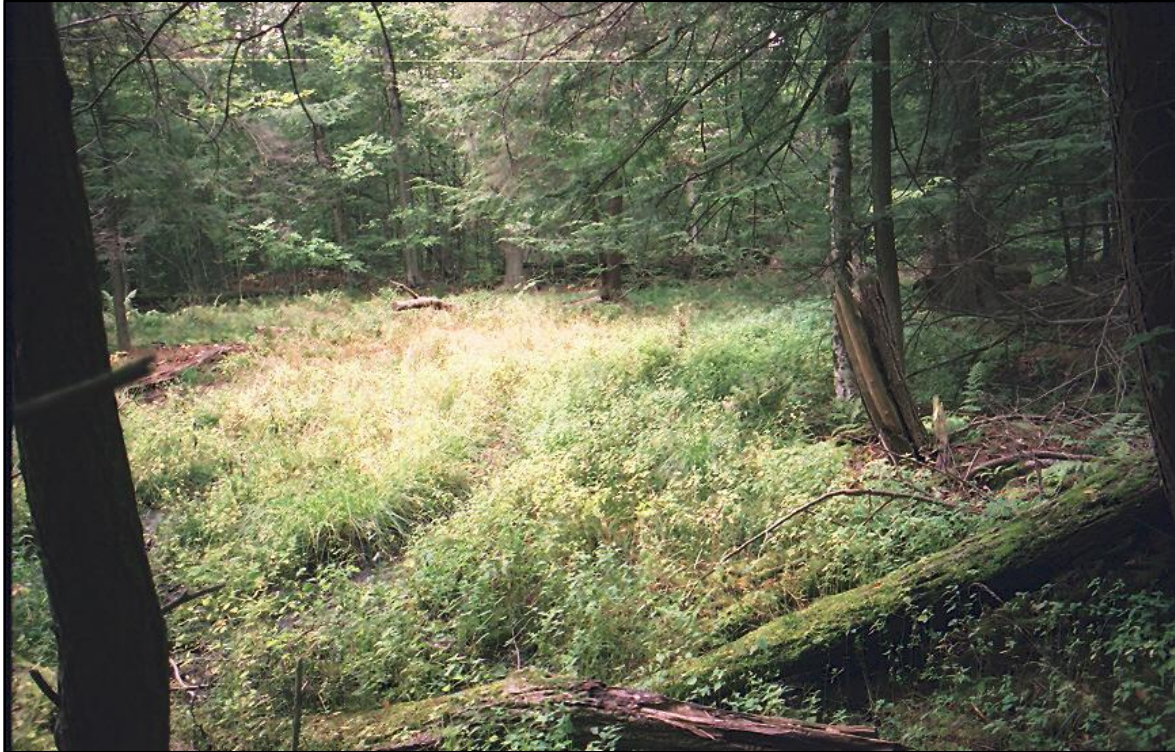
Photo 1. The wetland near flag H-1 has open, herb-dominated areas with *Impatiens capensis*, *Cinna latifolia*, *Glyceria striata*, *Carex stricta*, *C. lurida*, and *Juncus effusus*. On the edges are trees, mainly *Tsuga canadensis* and *Betula alleghaniensis*. (Photographed 9/15/99.)

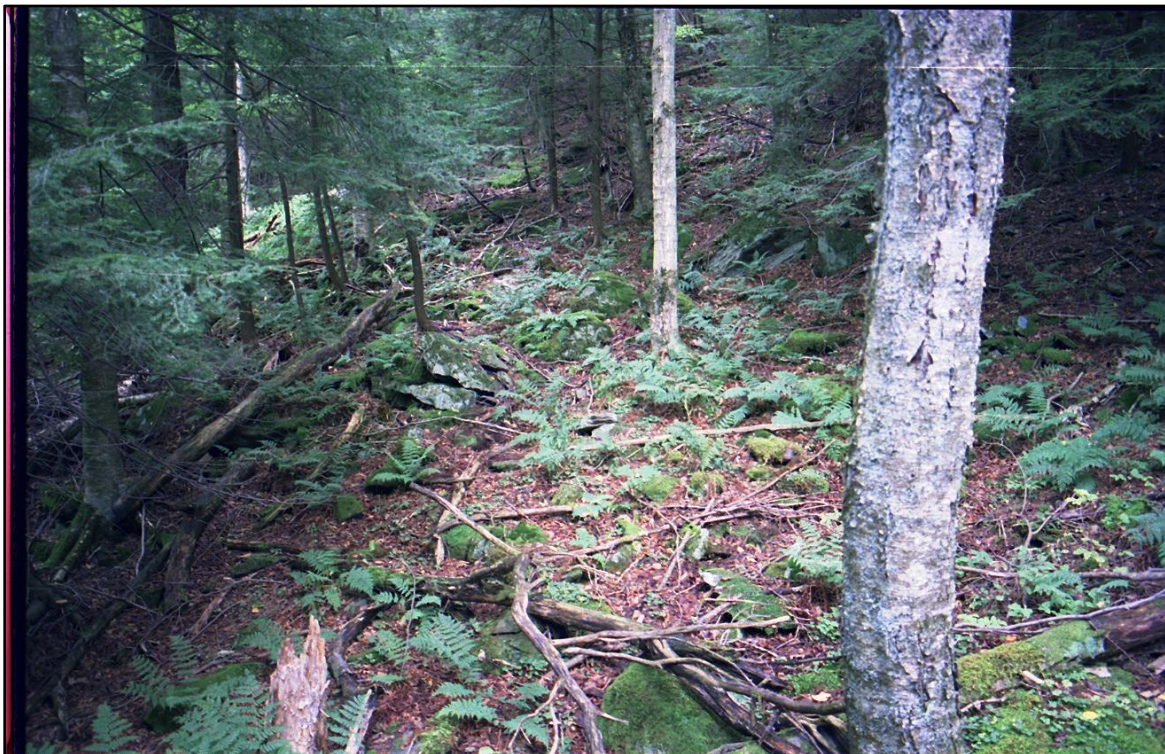
Photo 2. The upland next to boundary flag H-1 is a forest of *Tsuga canadensis*, *Betula alleghaniensis*, and *Acer saccharum*, with a shrub layer of *Viburnum lantanoides* and *T. canadensis* saplings. The herb layer is composed mainly of *Dryopteris intermedia*, *Oxalis montana*, and *Acer pensylvanicum* seedlings. (Photographed 9/15/99.)

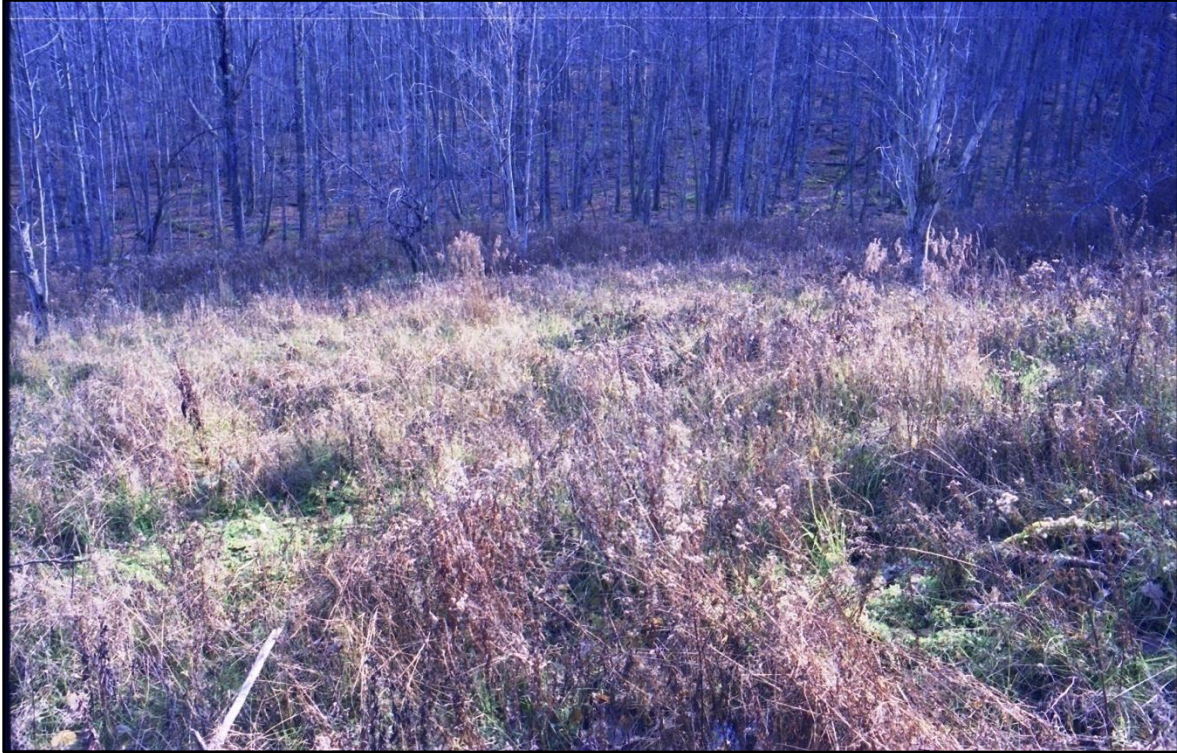
Photo 3. At flag AB-8, the wetland is a broad, seepy area dominated by herbs such as *Euthamia graminifolia*, *Myosoton aquaticum*, *Glyceria striata*, *Carex lurida*, *C. crinita*, *Epilobium coloratum*, and *Scirpus cyperinus*. (Photographed 11/5/99.)

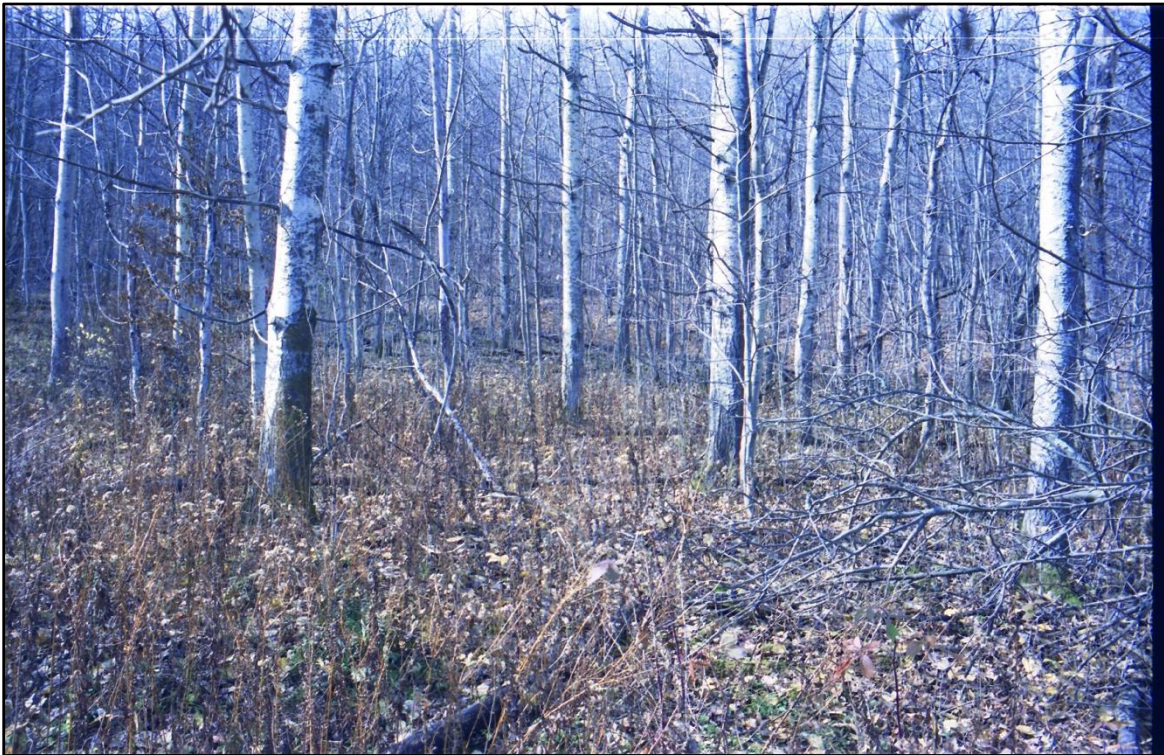
Photo 4. The upland near flag AB-8 is a young forest of tree- and sapling-size *Populus tremuloides*, *Acer rubrum*, *Malus sylvestris*, *Fraxinus americana*, *Ostrya virginiana*, and *Fagus grandifolia*. The herb layer has *Solidago canadensis*, *Fragaria virginiana*, and *Geum* sp. (Photographed 11/5/99.)

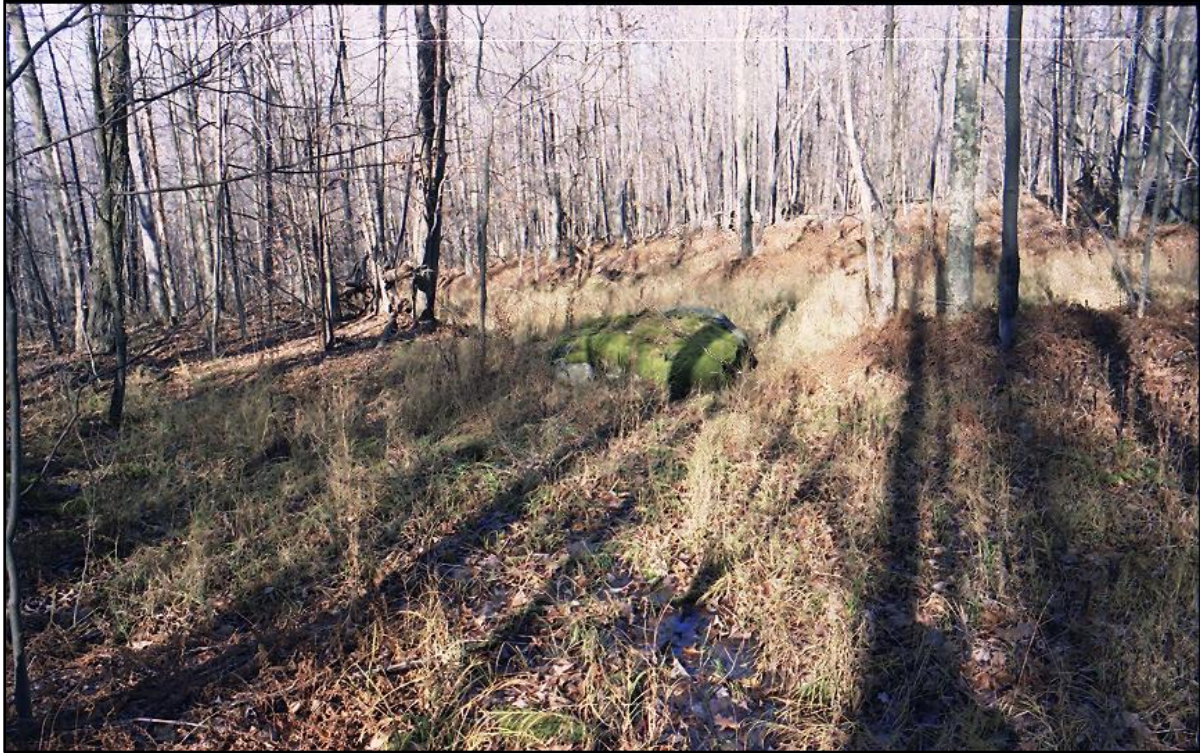
Photo 5. At the head of the wetland drainageway bounded by line AD is a seepy area with herbs, mainly *Glyceria melicaria*, *Onoclea sensibilis*, *Solidago canadensis*, and *Carex crinita*. There are a few saplings of *Acer rubrum* and *Ulmus americana*. (Photographed Nov. 5, 1999.)

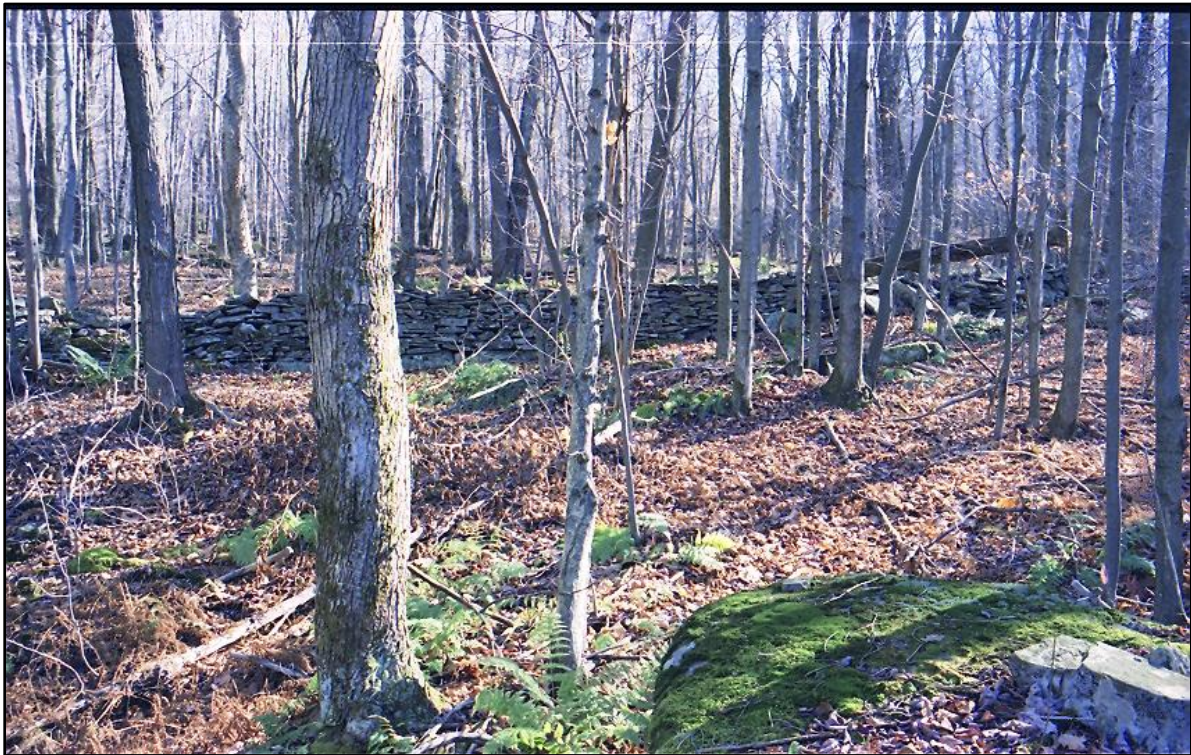
Photo 6. The upland forest near boundary flag AD-1 has *Acer saccharum*, *Betula alleghaniensis*, *Quercus rubra*, *Ostrya virginiana*, *Hamamelis virginiana*, *Dryopteris intermedia*, *Dennstaedtia punctilobula*, and *Polystichum achrostichoides*. (Photographed 11/5/99.)

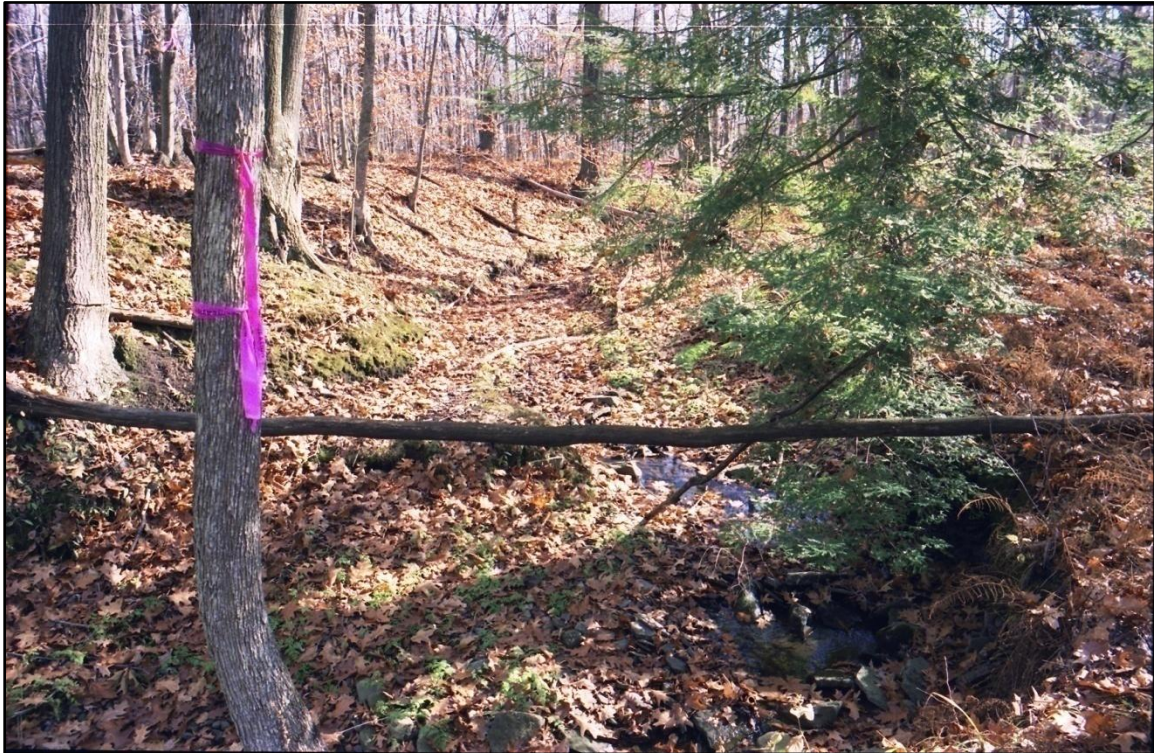
Photo 7. The upper reaches of the stream bounded by lines O, P, and HN, looking upstream near flag HN-25. This part of the stream is more seepy, with wetland plants such as *Glyceria striata*, *Anthriscus sylvestris*, *Mentha X piperita*, and *Impatiens* sp. (Photographed 10/28/99.)

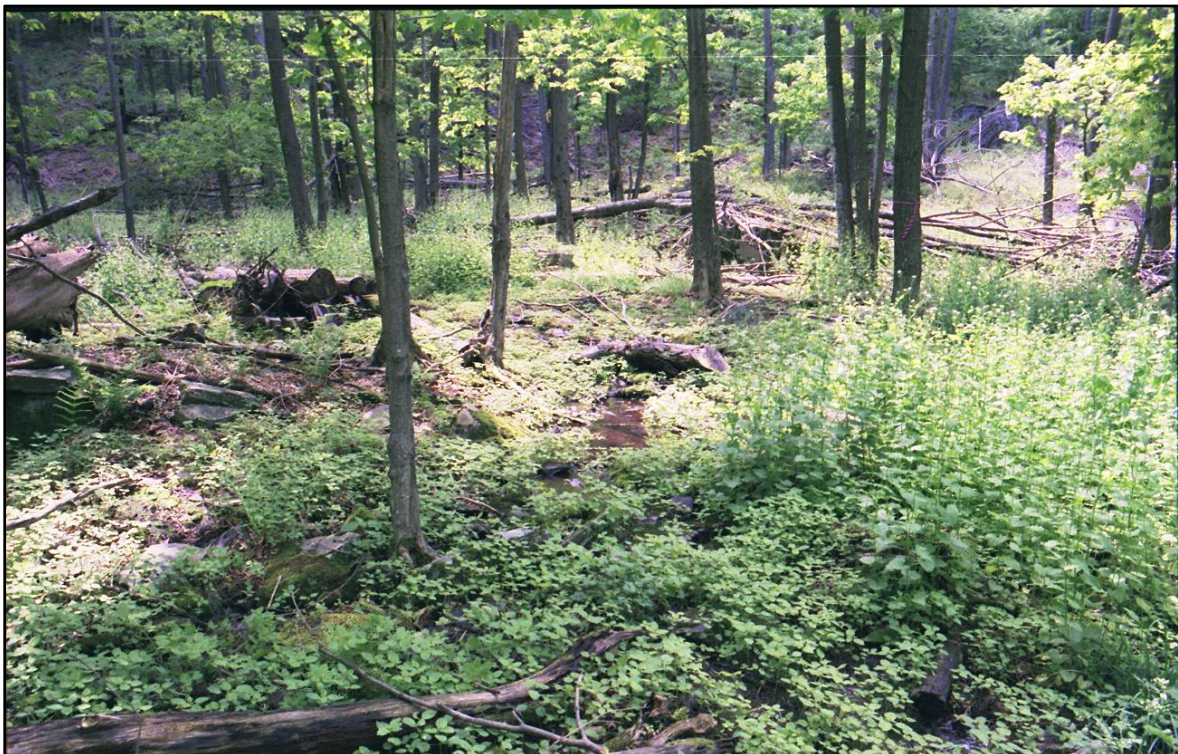
Photo 8. A view looking upstream from a point between flags CB-5 and CC-13. Plants in this wetland include *Acer saccharum*, *Fraxinus pennsylvanica*, *Impatiens* sp., *Glyceria* sp., *Arisaema triphyllum*, and *Alliaria petiolata*. (Photographed May 26, 2000.)

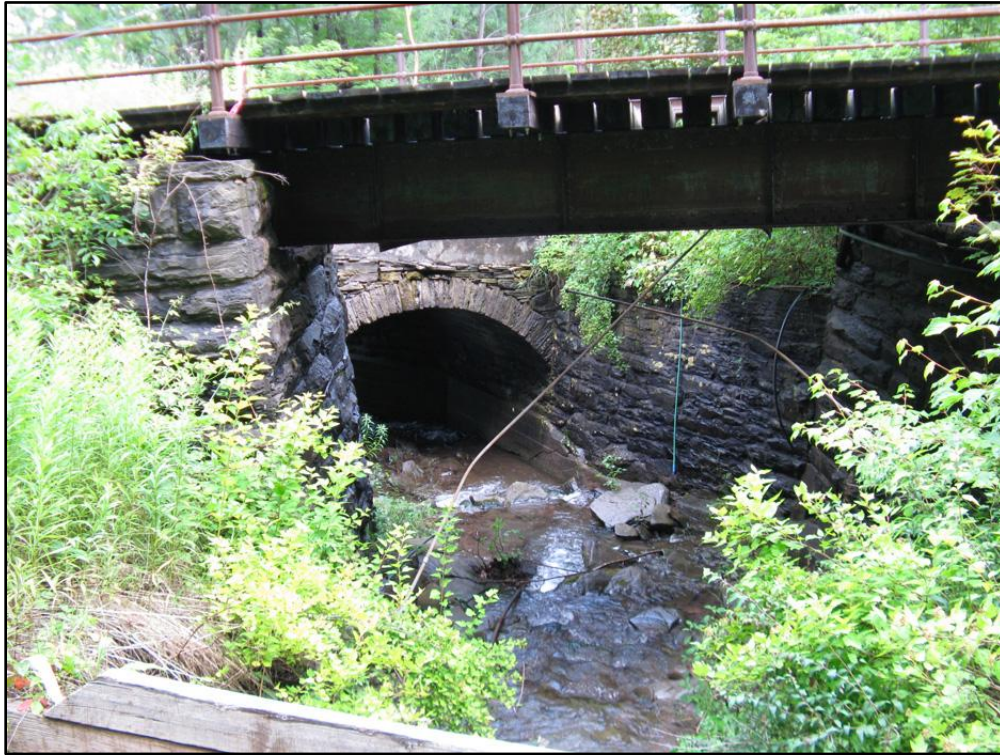
Photo 9. Todd Mountain Rd. Brook, viewed from south end of lines WA and WB, towards the railroad bridge and the road bridge (stone arch). The water supply line will be buried in the roadbed of Todd Mountain Road at that bridge. (Photographed July 30, 2009).

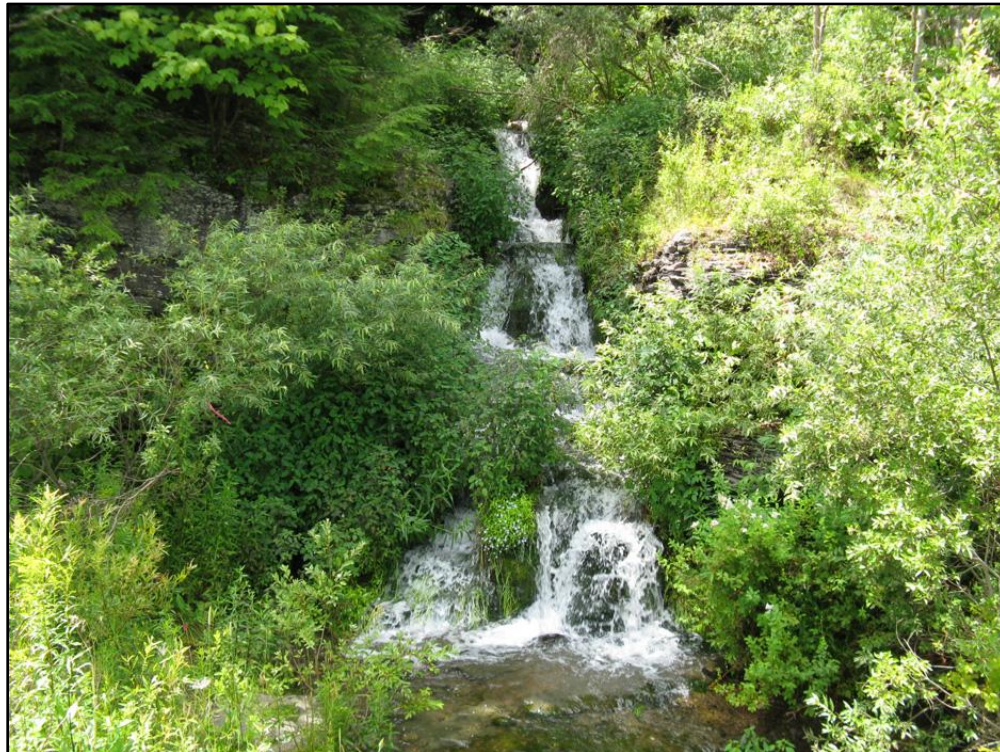
Photo 10. Highmount Brook, viewed from NYS Route 28, at the south end of boundary lines WC and WD. (Photographed July 30, 2009).

Approximately 1.1 miles east of the K-well site, the water line crosses Highmount Brook (Drawing PN3). Lines WC and WD were delineated on the west and east sides, respectively of an 83-foot-long section of the stream (see Photo 10). The delineation includes the part of the stream flowing through a culvert under NYS Route 28. Flags WC-2 and WD-3 are at the south (upstream) end of the culvert, and flags WC-3 and WD-4 are at its north end. This culvert has a small sign indicating that it has an ID number of C963037.

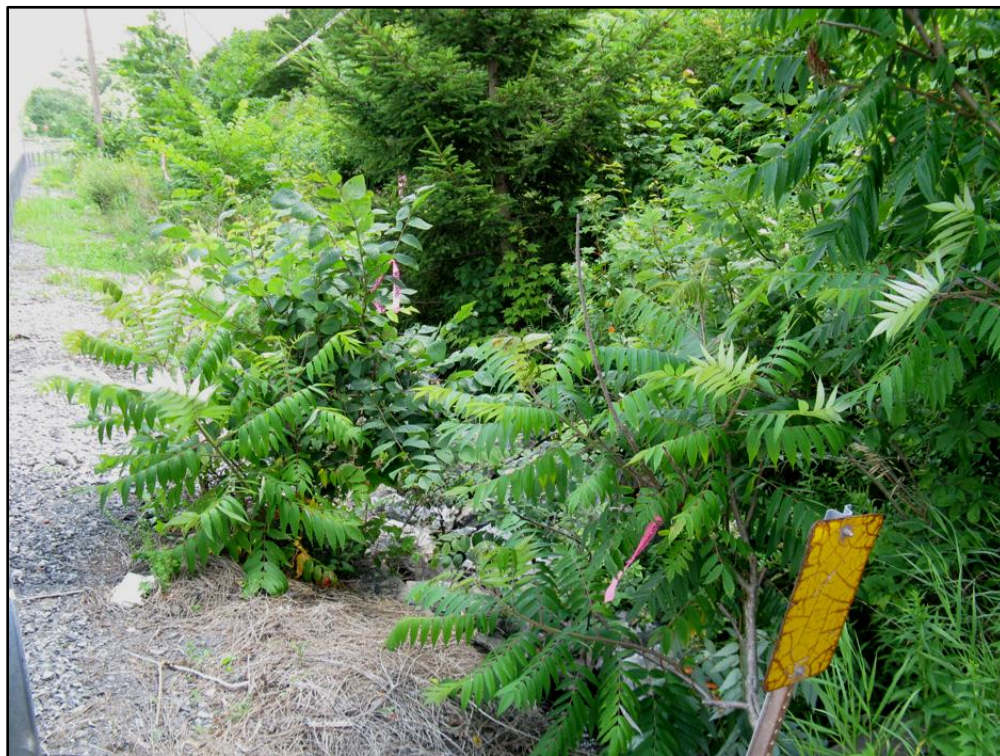
Photo 12. The segment of Wildacres Brook that runs along NYS Route 28, delineated with lines WH and WG (flag WH-4 in center foreground). A water supply line will be installed in a horizontal borehole in the hillside to the right of the stream. (Photographed July 30, 2009).

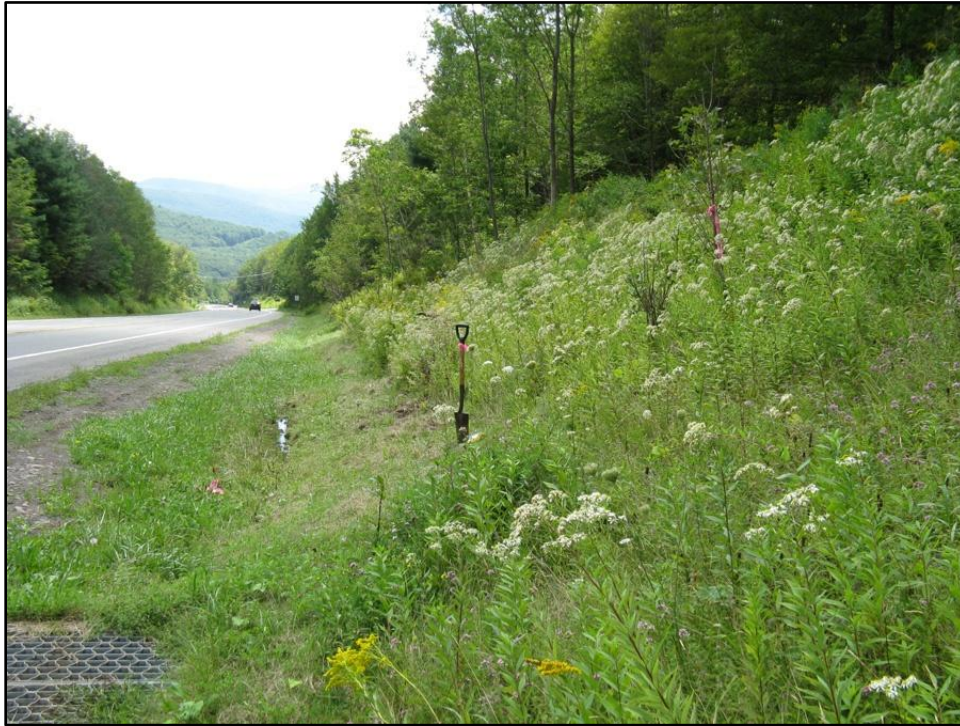
Photo 13. View of the western end of the wetland bounded by line WM. This is a seepy roadside bank that drains into the ditch along NYS Route 28. Dominant plants here include *Aster umbellatus*, *Euthamia graminifolia*, *Equisetum arvense*, *Polygonum sagittatum*, *Impatiens capensis*, *Salix eriocephala*, and *Fraxinus pennsylvanica*. (Photographed Aug. 24, 2009.)

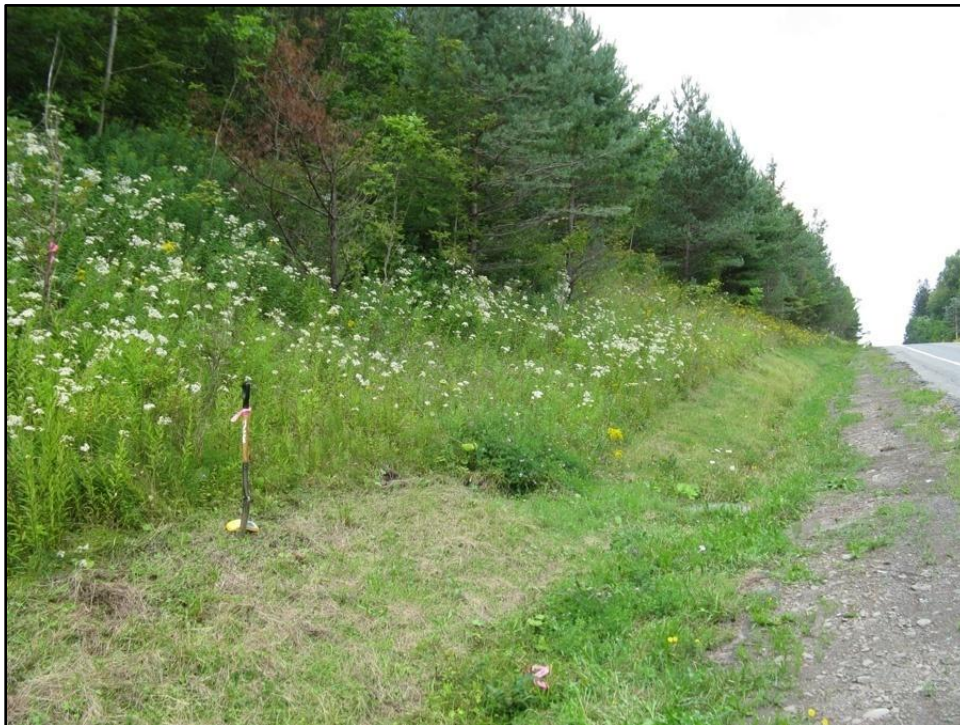
Photo 14. View of the upland near the western end of the wetland bounded by line WM. This part of the roadside bank is covered with *Pinus sylvestris*, *Acer saccharum*, *Fraxinus pennsylvanica*, *Aster umbellatus*, *Solidago canadensis*, *Origanum vulgare*, *Clinopodium vulgare*, and *Anthoxanthum odoratum*. (Photographed Aug. 24, 2009.)

The WM line marks a seepy embankment in the right-of-way of NYS Route 28 between its intersections with County Route 49A and Pine Hill Road (Drawing PN11). This wetland drains into the roadside ditch, which flows southeastward, eventually emptying into Birch Creek (see Photos 13 and 14).

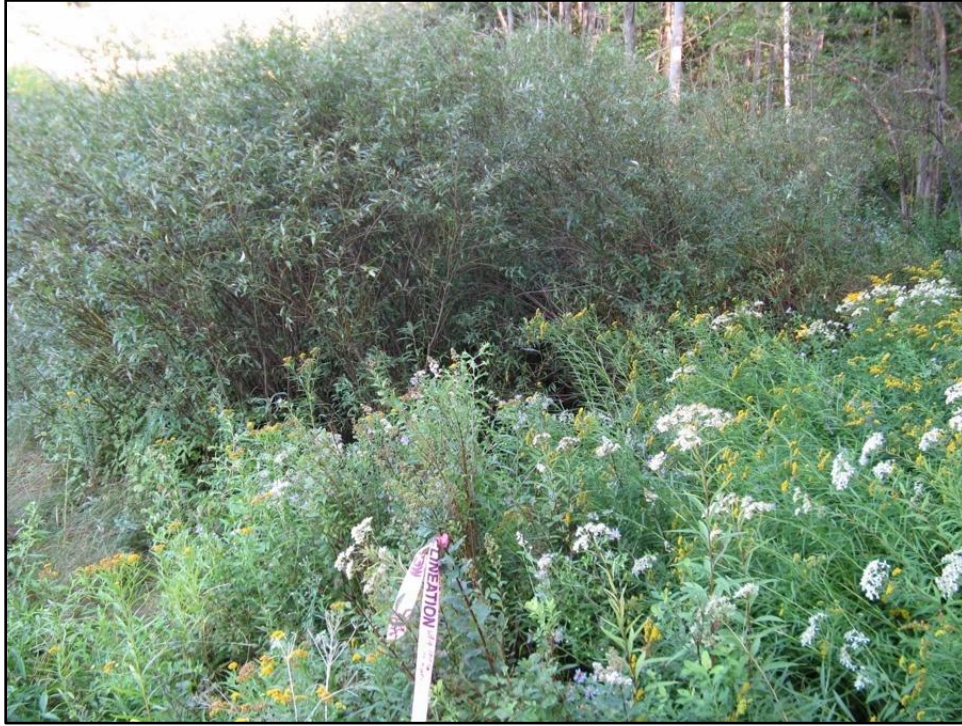
Photo 15. The wetland bounded by line WP, viewed from near flag WP-9, in foreground. Dominant plants include *Salix eriocephala*, *Spiraea alba*, *Carpinus caroliniana*, *Aster puniceus*, *Euthamia graminifolia*, and *Epilobium coloratum*. When this photo was taken, on August 24, 2009, there was standing water at the base of the shrub willows shown here.

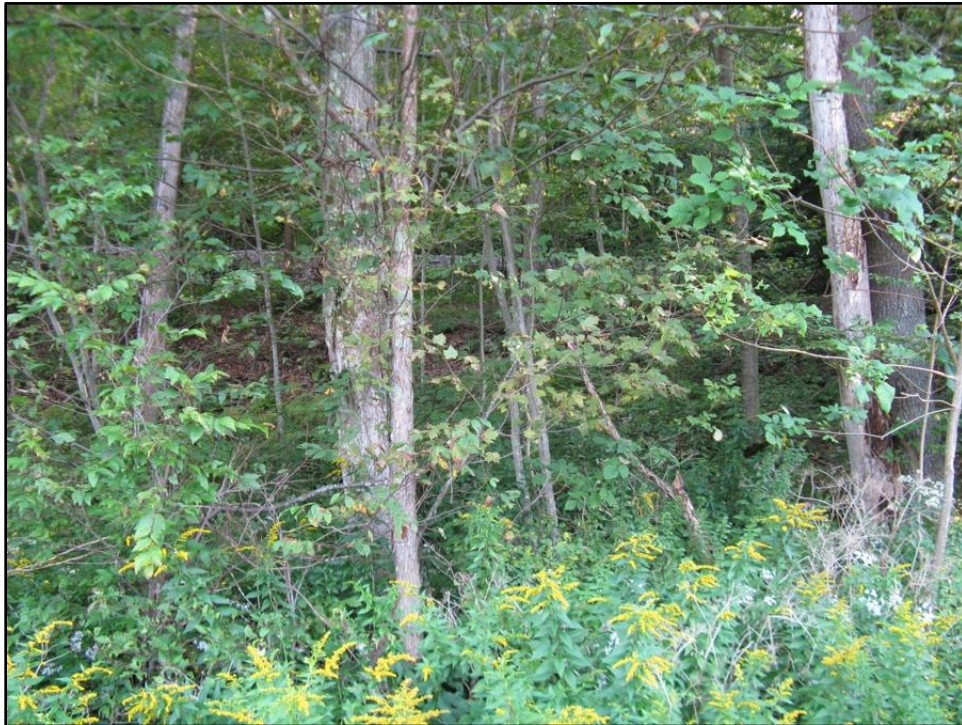
Photo 16. The upland near the west end of the wetland bounded by line WP. Has a tree layer of *Prunus serotina*, *Acer saccharum*, with saplings of *Carpinus caroliniana* and *Fraxinus pennsylvanica*. The herb layer dominants are *Solidago canadensis*, *Dryopteris intermedia*, and *Anthriscus sylvestris*. (Photographed Aug. 24, 2009.)

Line WP surrounds an isolated area of shallow emergent marsh and shrub swamp situated at the point where the sewer line coming down from the Wildacres area will reach NYS Route 28 and turn eastward (Drawing PN6). Photos 15 and 16 are views of this area. There are no streams entering or leaving this 0.15-acre patch of wetland.

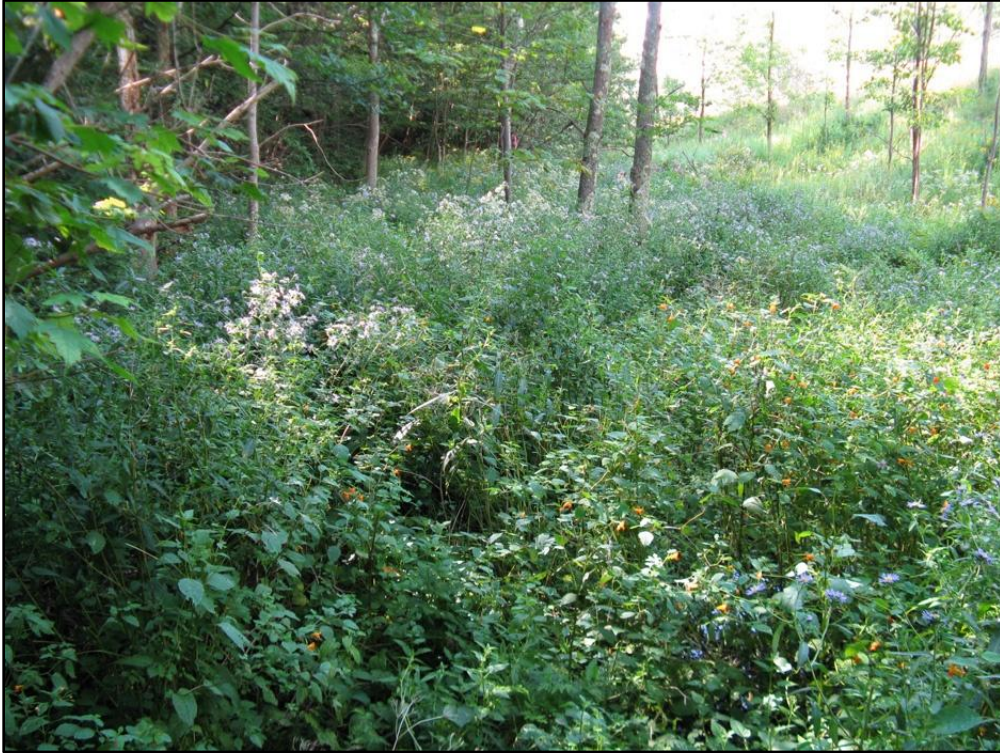
Photo 17. View of off-site wetland WN/WO from its east end. It is dominated by *Impatiens capensis*, *Aster puniceus*, *A. umbellatus*, and *Fraxinus pennsylvanica*. (Photographed Aug. 24, 2009.)

Lines WN and WO mark a stream/wetland complex west of the County Route 49A intersection with NYS Route 28 (Drawing PN6). This linear, 0.24-acre wetland is covered with shallow emergent marsh vegetation with some small green ash trees (see Photo 17). A small stream enters the wetland at its eastern end, and exits at its western end, where it flows into a culvert under NYS Route 28. This is a first-order stream which is a tributary of Emory Brook. The sewer line route runs parallel to, but outside of this wetland.

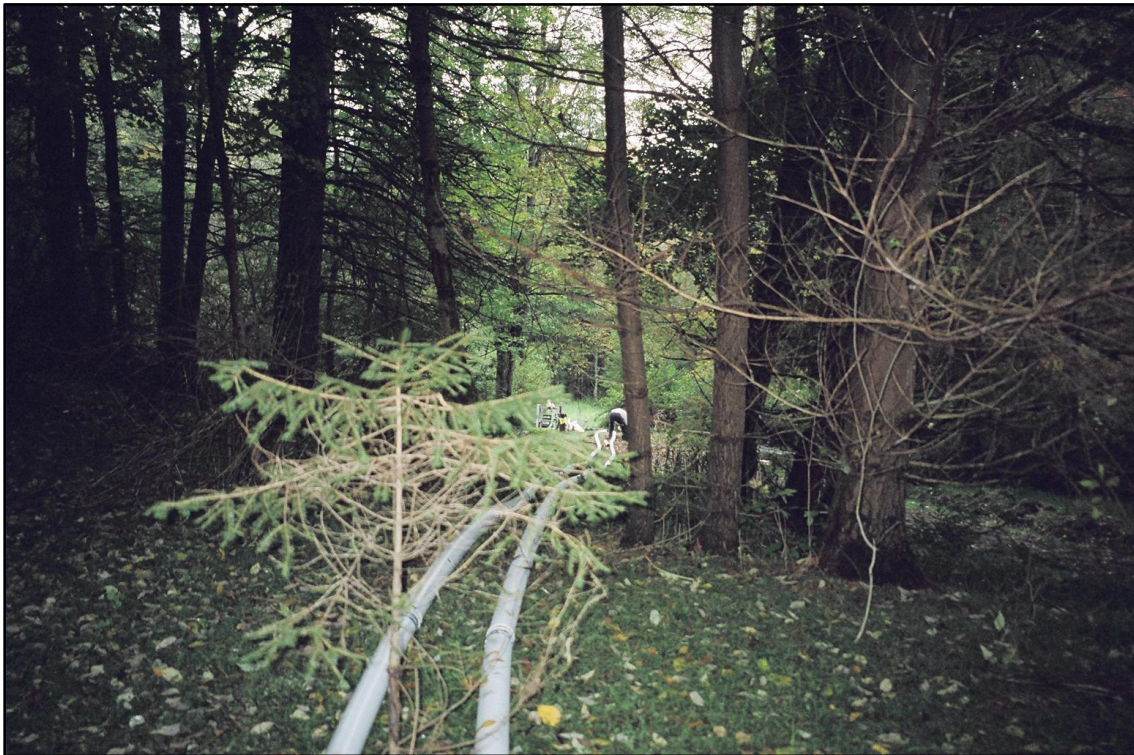
Photo 18. On the K-Well Parcel, a view looking downhill from well K-4, the one farthest uphill. (Photographed Sept. 2007.)

More recently, two parcels on which potable water supply wells are located have been added to the site. One of these, known as the K-well parcel, is located north of the Adelstein parcel near the intersection of Todd Mountain Road with NYS Route 28. Although this parcel is 35.08 acres in size, only a 3.7-acre portion in its northeast corner, which contains three wells, is included in the area for which a Jurisdictional Determination is requested. Currently Crossroads Ventures has an option to purchase this property from its current owner, Kenneth D. Pasternak. The other parcel added, known as the Q-well parcel (Quarry parcel), is located north of the Wildacres Resort part of the site, on Moran Road near its intersection with NYS Route 28. This parcel, which occupies 9.57 acres, has only one well. Photos 18 through 24 in Appendix C show views of these two parcels.
