**USACOE UPDATED DELINEATION REPORT &
JURISDICTIONAL DETERMINATION REQUEST**

SUBJECT: Permit Application Number NAN-2010-00313-WOR
by Crossroads Ventures, LLC

THE MODIFIED BELLEAYRE RESORT AT CATSKILL PARK, NAN-2000-00748-WETLAND DELINEATION REPORT

Town of Shandaken & Town of Middletown, New York

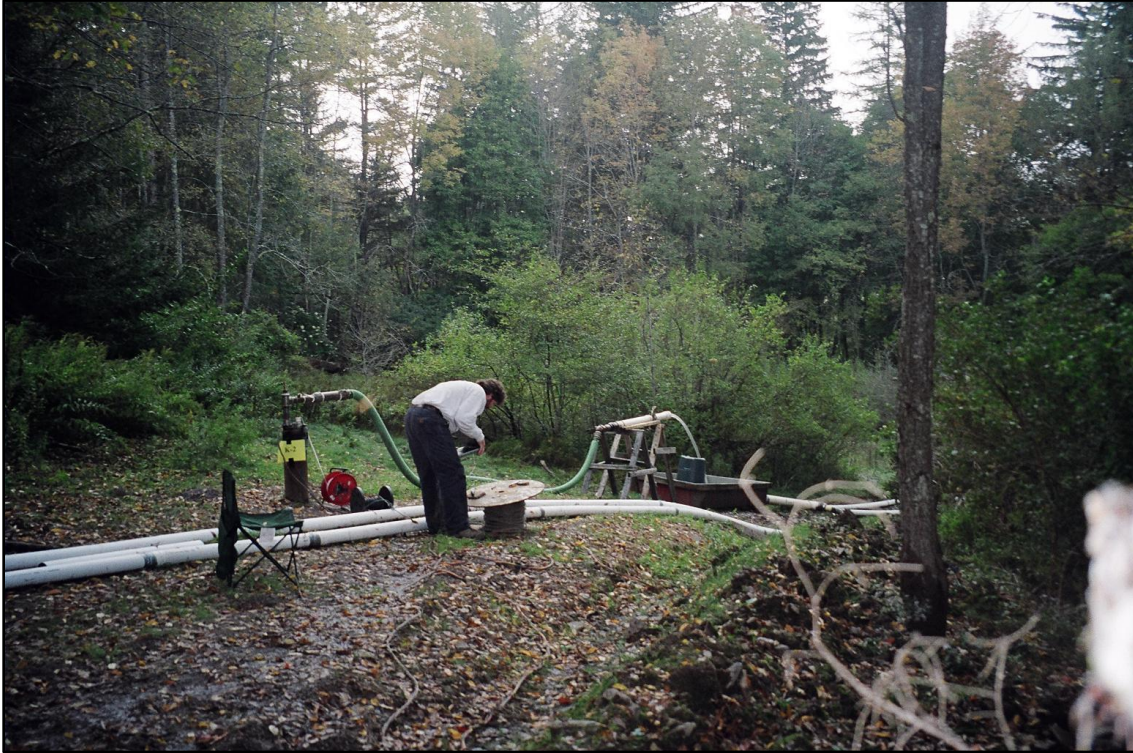
Photo 19. Well K-2. (Photographed Sept. 2007.)

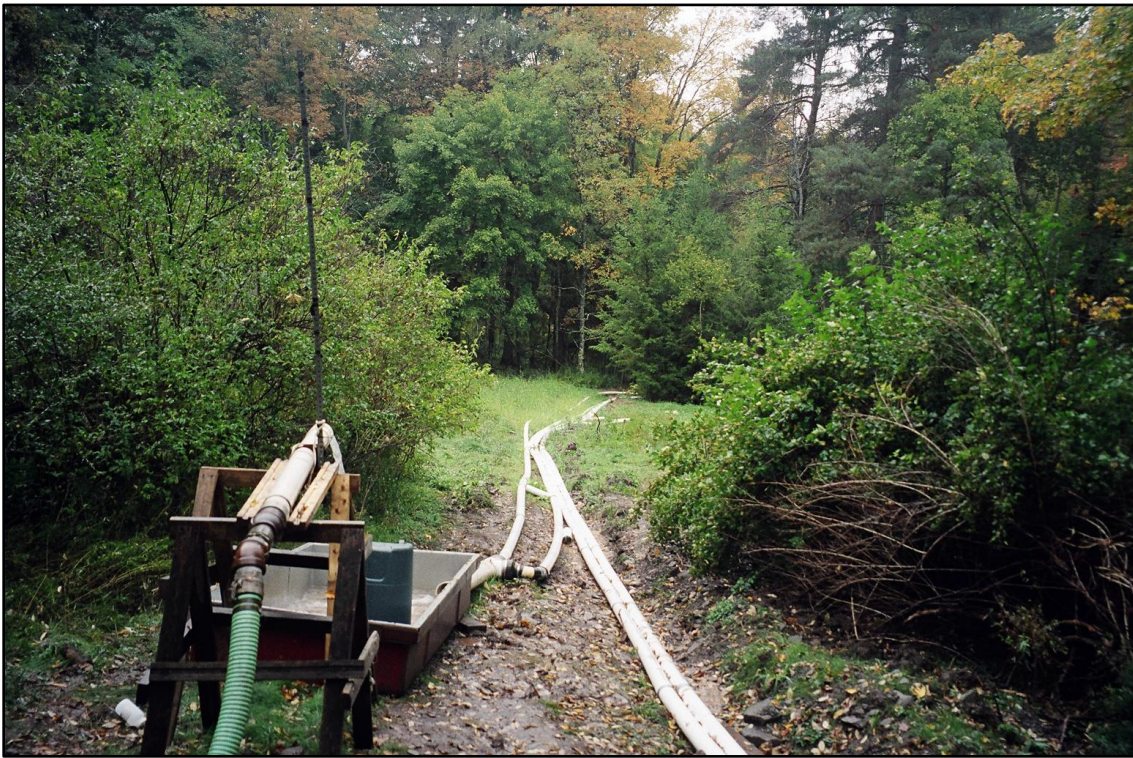
Photo 20. View from well K-2 towards well K-1, which is just out of site. Well K-3 is out of sight, just off to the right. (Photographed Sept. 2007.)

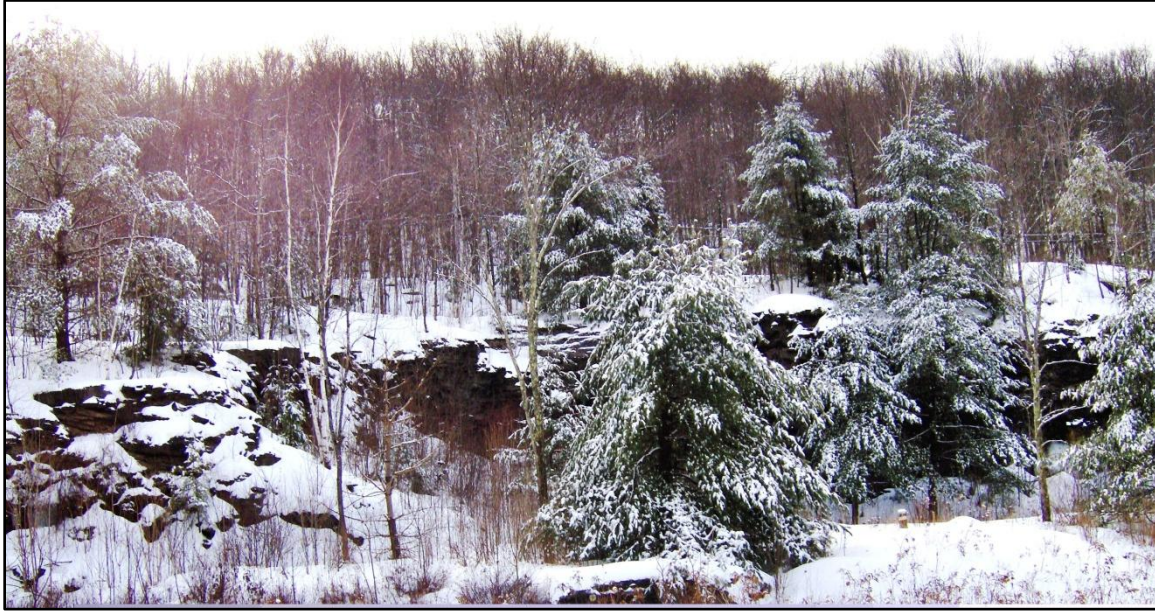
Photo 21. View of the east end of the quarry parcel, as seen from Moran Rd. The well is in front of the pine trees in the right half of the photo. (Photographed January 14, 2010.)

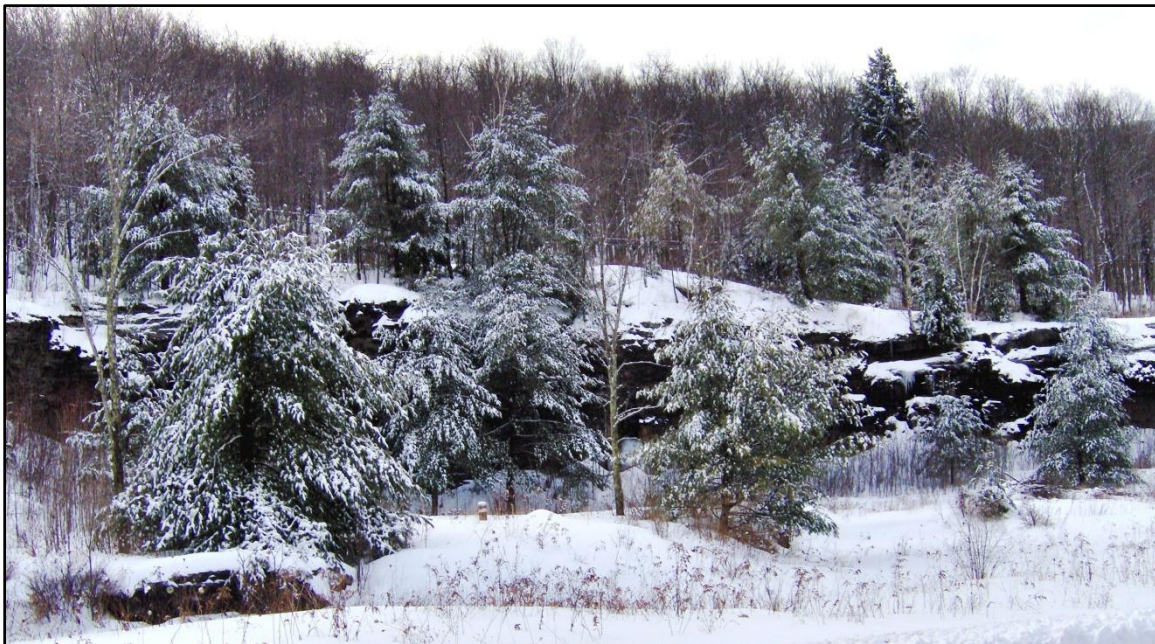
Photo 22. View of the east-central part of the quarry parcel, as seen from Moran Rd. The existing well is visible to the right of center, between the two closest conifer trees. (Photographed January 14, 2010.)
