Wetland Delineation Report

The Belleayre Resort at Catskill Park

**FEDERAL WETLAND
DELINEATION REPORT
FOR
BELLEAYRE RESORT
AT THE CATSKILL PARK**

**TOWN OF SHANDAKEN, ULSTER COUNTY
TOWN OF MIDDLETOWN, DELAWARE COUNTY
NEW YORK**

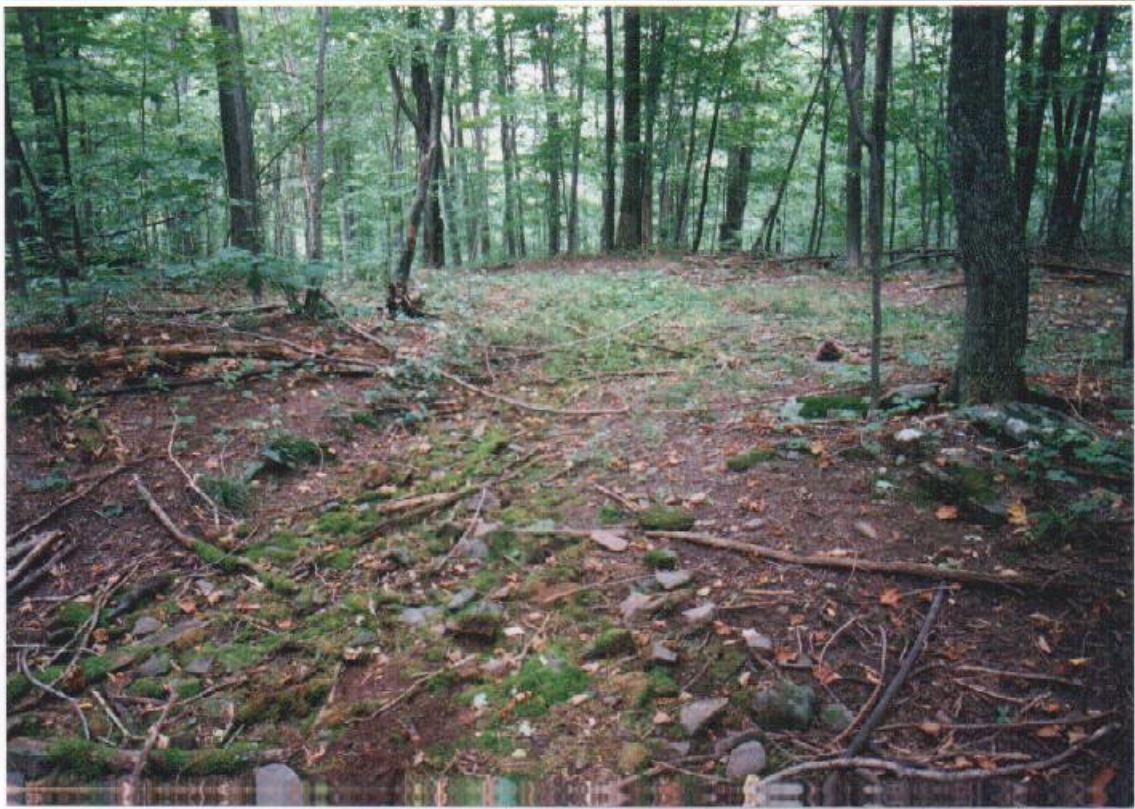
Photo 1. The wetland at boundary flag A-2 is a narrow, shallow drainageway that flows intermittently. It is discernible as the area of moss-covered rocks in the center of this view. The few plants in this area include *Impatiens capensis*, *Chrysosplenium americanum*, and *Tiarella cordifolia*. Adjacent uplands are dominated by *Acer saccharum*, *Fraxinus americana*, *Ostrya virginiana* and *Acer pensylvanicum*. (Photographed 9/14/99).

Wetlands A and B/C. Wetland A is a narrow drainageway occupied by an intermittent stream that begins in a spring hole at the base of a small scarp, then runs downhill a few hundred feet, eventually disappearing into the rocky substratum. Among the few plants found in this wetland were *Impatiens capensis*, *Chrysosplenium americanum*, *Tiarella cordifolia*, *Rumex obtusifolius*, and unidentified grasses. The surrounding upland is a hardwood forest of *Acer saccharum*, *Fraxinus americana*, *Fagus grandifolia*, *Ostrya virginiana*, *Betula alleghaniensis*, and some *Tsuga canadensis*. Wetland B/C lies a short distance downslope, and has similar vegetation, but with the addition of ferns, including

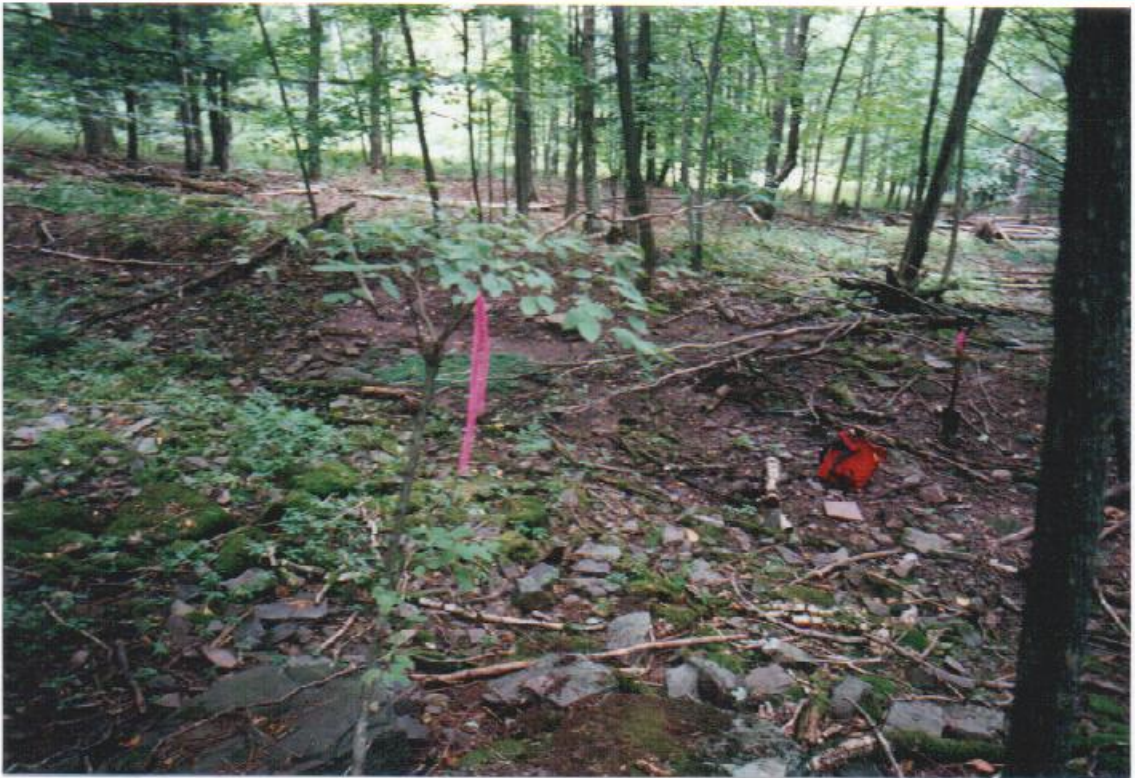
Photo 2. Near boundary flag B-1, the wetland is a small basin at the head of a rocky drainageway. The sparse vegetation includes *Impatiens capensis*, *Chrysosplenium americanum*, *Onoclea sensibilis*, and *Dryopteris spinulosa*. (Photographed 9/14/99.)

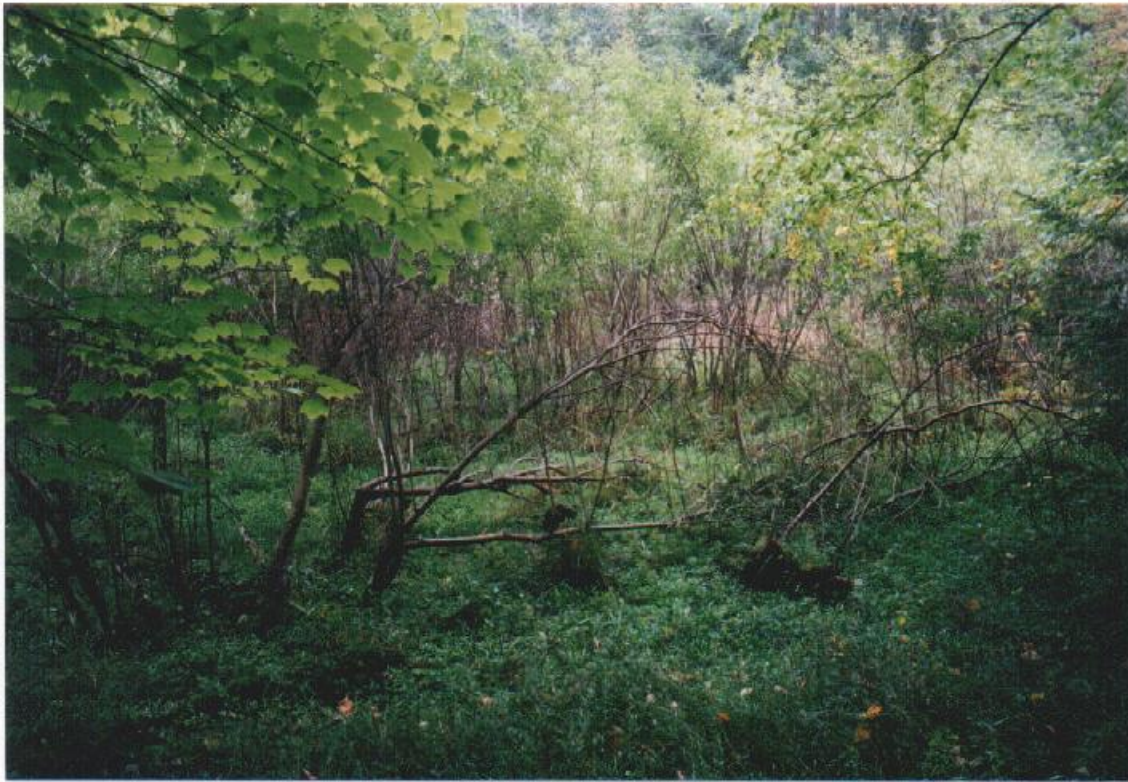
Photo 3. Wetland D, on the floodplain of Birch Creek (flag D-25) has a shrub swamp of *Salix nigra*, *Myosotis scorpioides*, *Scirpus microcarpus*, *Impatiens* sp., and *Onoclea sensibilis*. The soil was saturated to the surface. (Photographed 9/15/99.)

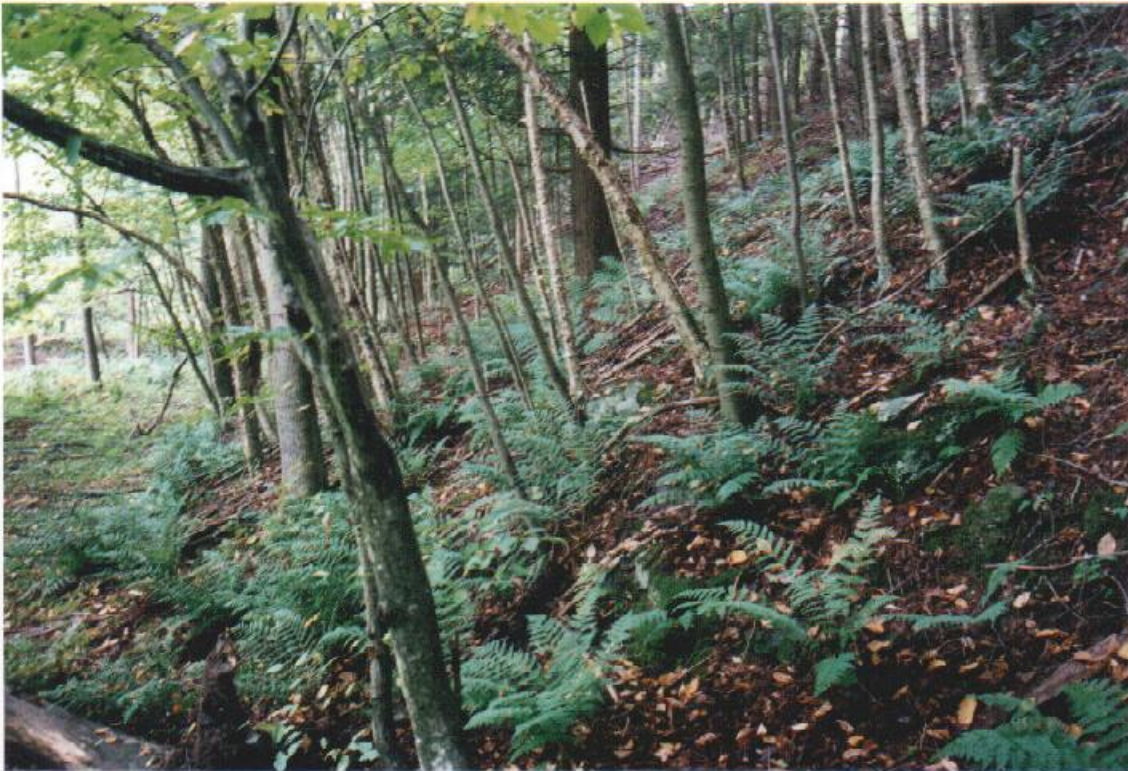
Photo 4. The upland near wetland boundary flag D-25 is a steep slope with *Tsuga canadensis*, *Acer saccharum*, *Betula alleghaniensis*, *B. lenta*, *Carpinus carolina*, *Dryopteris spinulosa*, *D. marginalis*, and *Thelypteris noveboracensis*. (Photographed 9/15/99.)

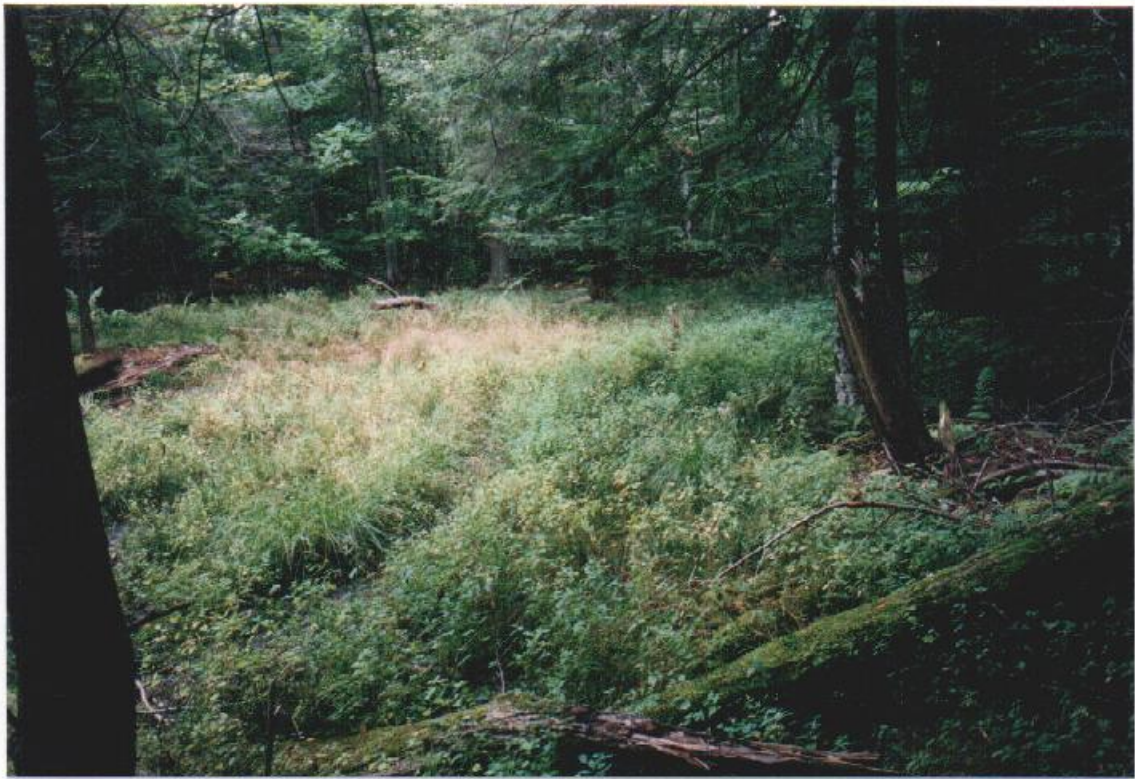
Photo 5. The wetland near flag H-1 has open, herb-dominated areas with *Impatiens capensis*, *cinna latifolia*, *Glyceria striata*, *Carex stricta*, *C. lurida*, and *Juncus effusus*. On the edges are trees, mainly *Tsuga canadensis* and *Betula alleghaniensis*. (Photographed 9/15/99.)

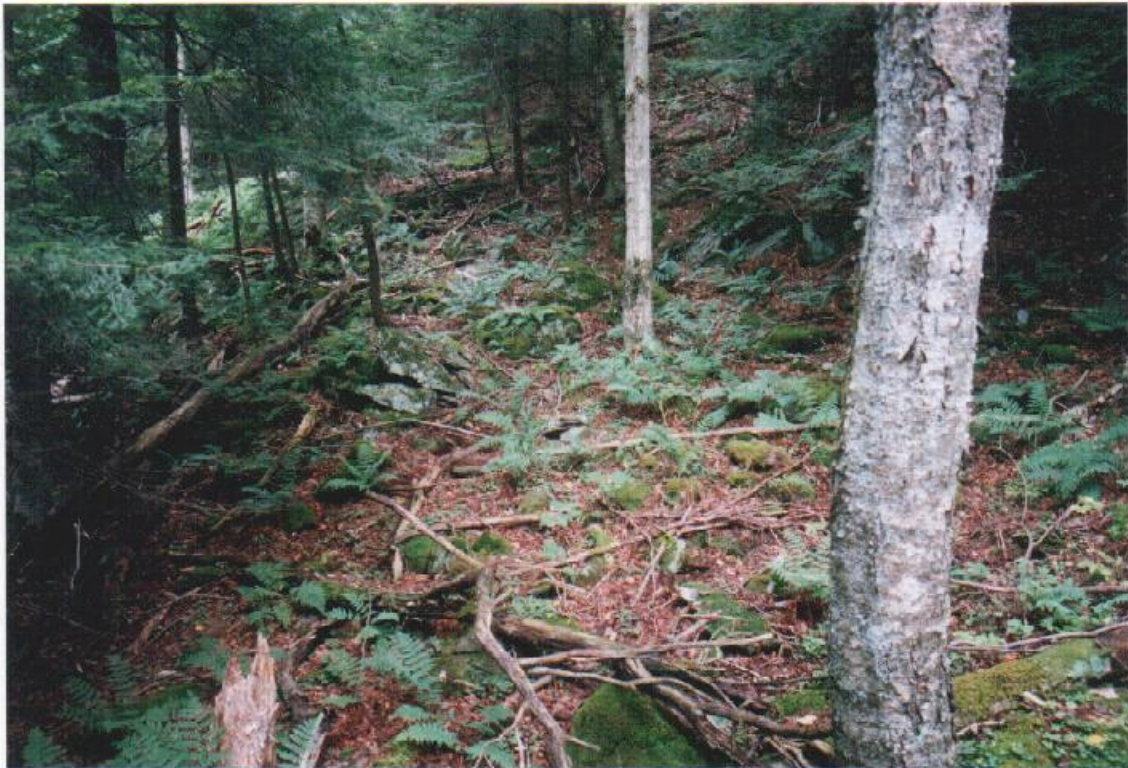
Photo 6. The upland next to boundary flag H-1 is a forest of *Tsuga canadensis*, *Betula alleghaniensis*, and *Acer saccharum*, with a shrub layer of *Viburnum lantanoides* and *T. canadensis* saplings. The herb layer is composed mainly of *Dryopteris spinulosa*, *Oxalis montana*, and *Acer pensylvanicum* seedlings. (Photographed 9/15/99.)

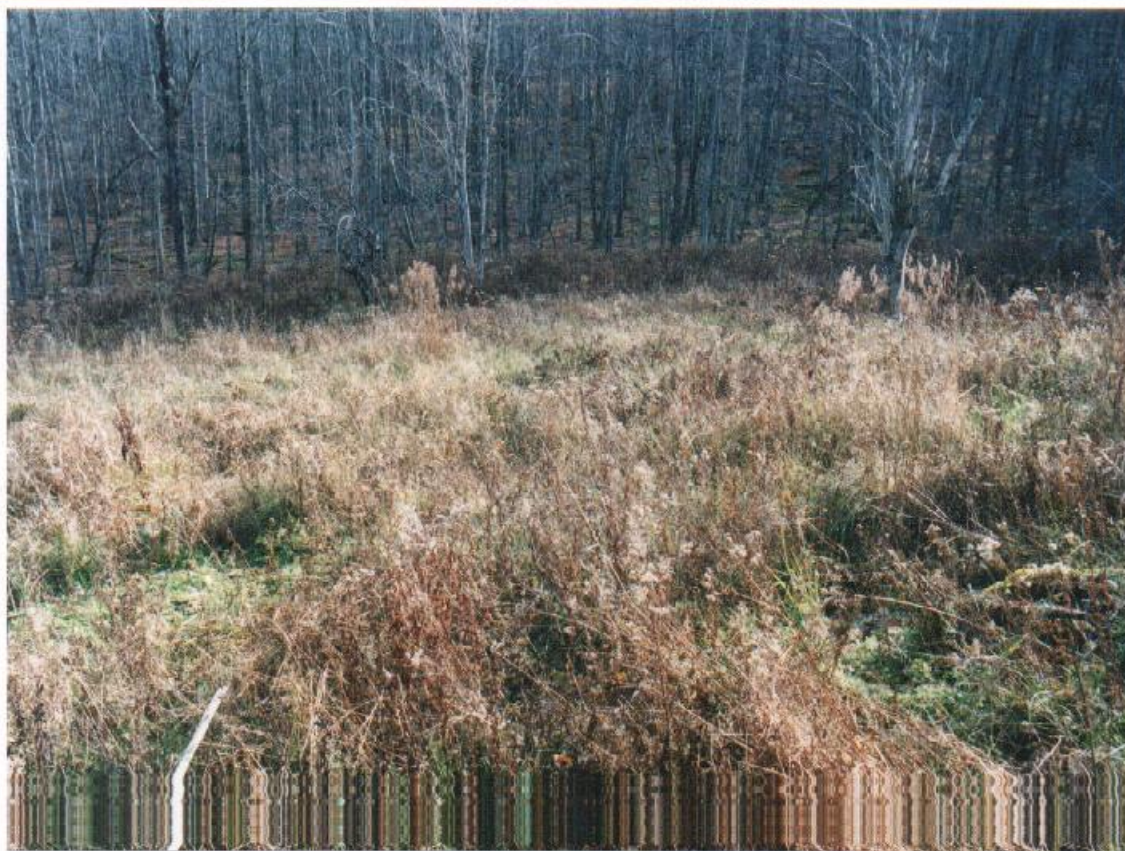
Photo 7. At flag AB-8, the wetland is a broad, seepy area dominated by herbs such as *Euthamia graminifolia*, *Myosoton aquaticum*, *Glyceria striata*, *Carex lurida*, *C. crinita*, *Epilobium coloratum*, and *Scirpus cyperinus*. (Photographed 11/5/99.)

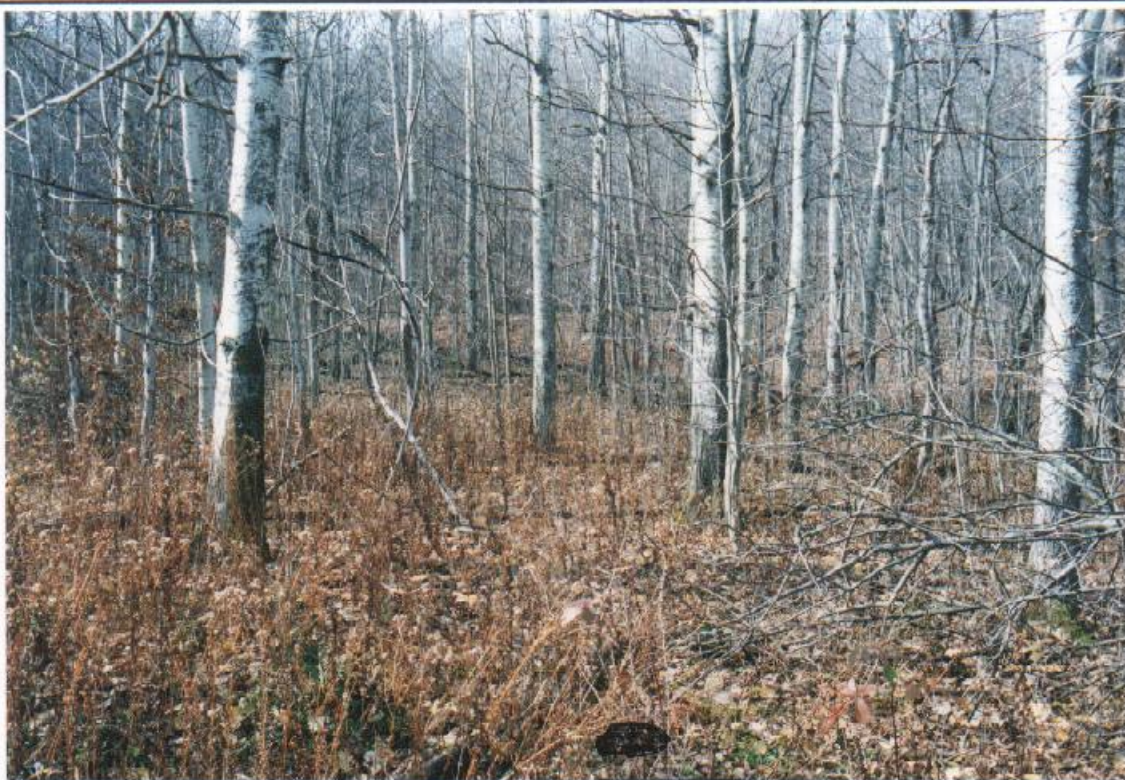
Photo 8. The upland near flag AB-8 is a young forest of tree- and sapling-size *Populus tremuloides*, *Acer rubrum*, *Malus sylvestris*, *Fraxinus americana*, *Ostrya virginiana*, and *Fagus grandifolia*. The herb layer has *Solidago canadensis*, *Fragaria virginiana*, and *Geum* sp. (Photographed 11/5/99.)

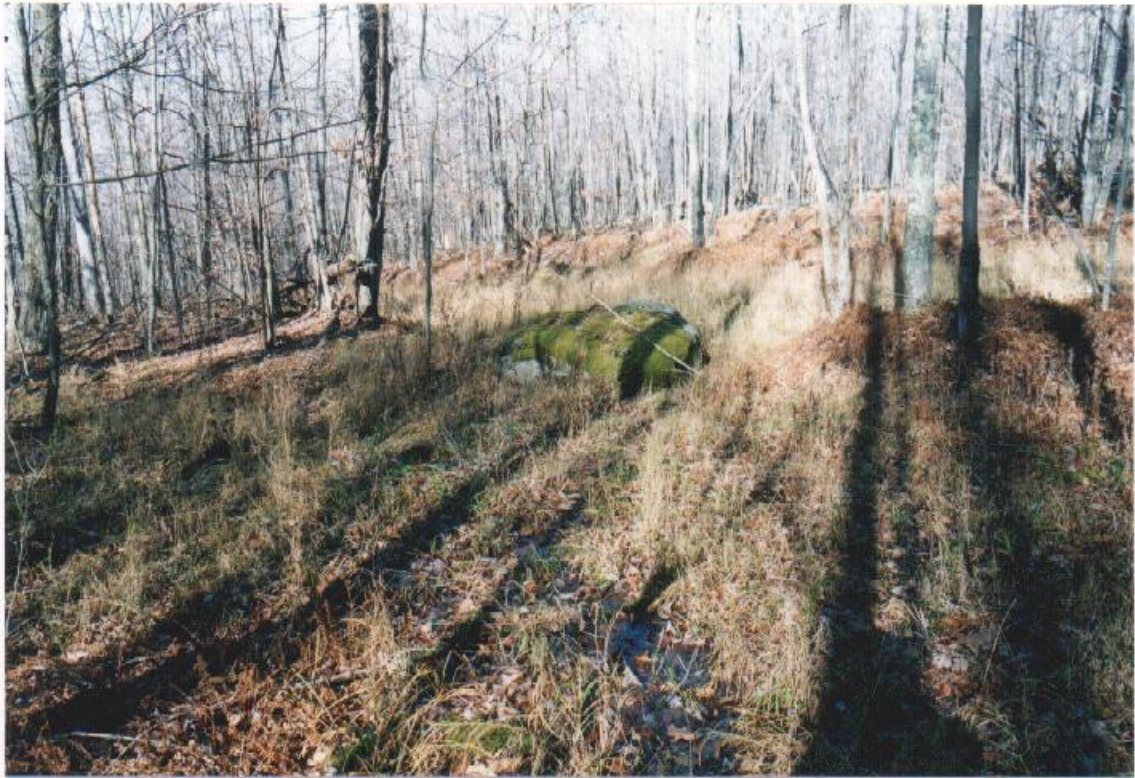
Photo 9. At the head of the wetland drainageway bounded by line AD is a seepy area with herbs, mainly *Glyceria melicaria*, *Onoclea sensibilis*, *Solidago canadensis*, and *Carex crinita*. There are a few saplings of *Acer rubrum* and *Ulmus americana*. (Photographed Nov. 5, 1999.)

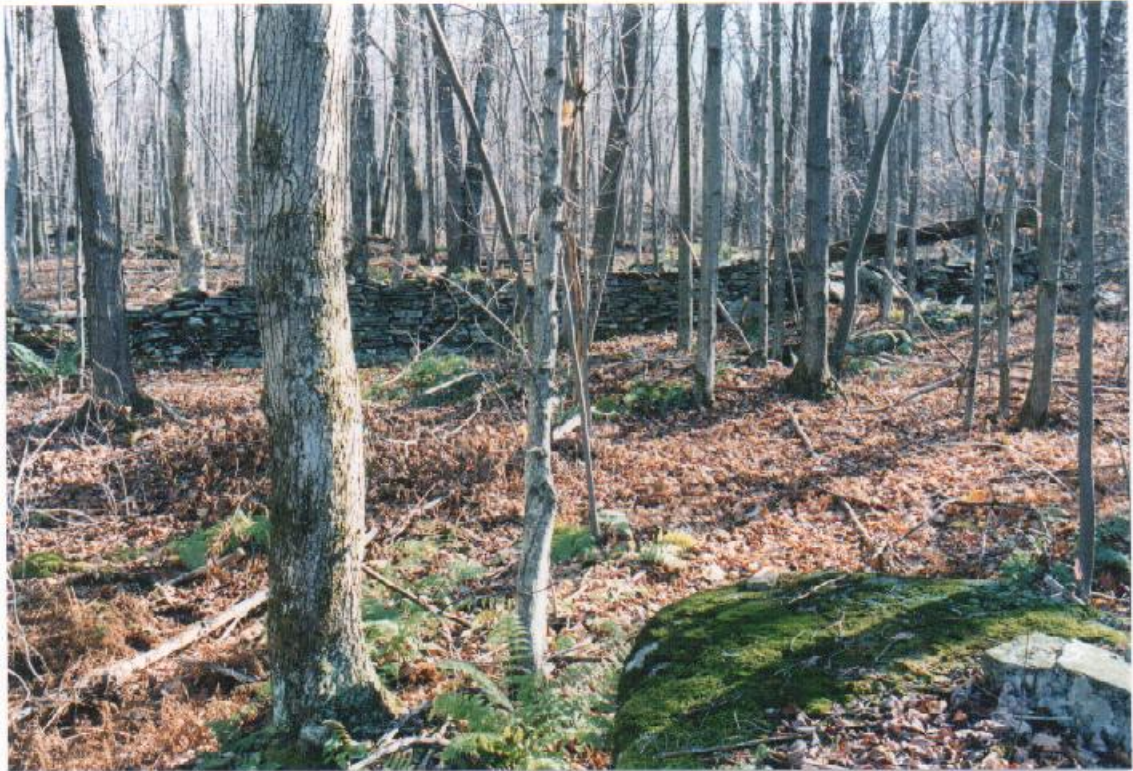
Photo 10. The upland forest near boundary flag AD-1 has *Acer saccharum*, *Betula alleghaniensis*, *Quercus rubra*, *Ostrya virginiana*, *Hamamelis virginiana*, *Dryopteris spinulosa*, *Dennstaedtia punctilobula*, and *Polystichum achrostichoides*. Photographed 11/5/99.

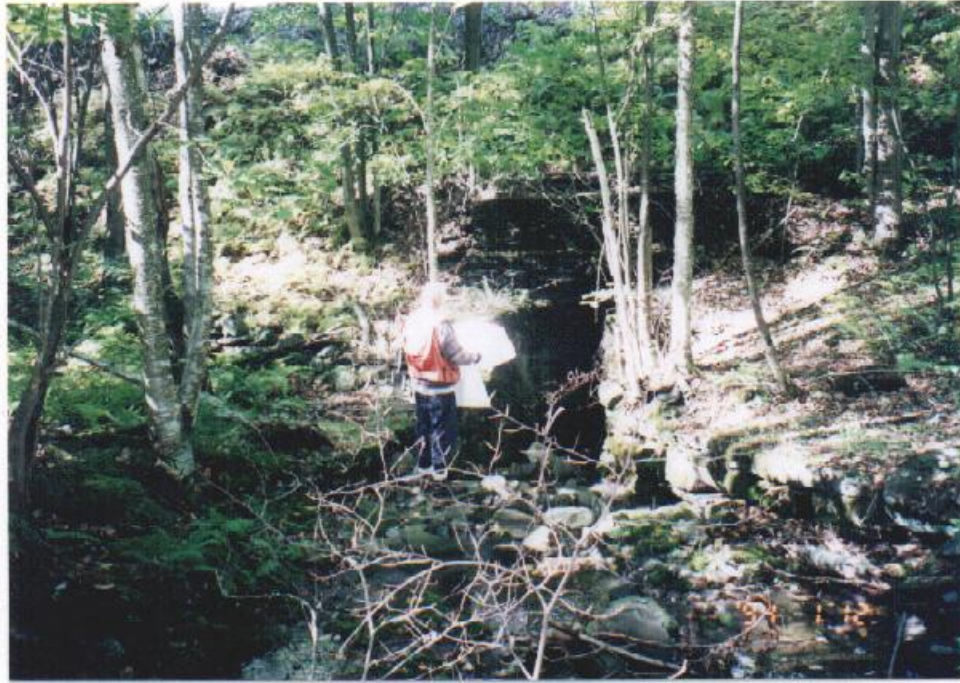
Photo 11. View of the rocky stream bounded by lines Q and R, at its lower end, where it enters a culvert under the old railroad tracks. The stream has steep banks and little wetland vegetation. (Photographed Sept. 23, 1999).

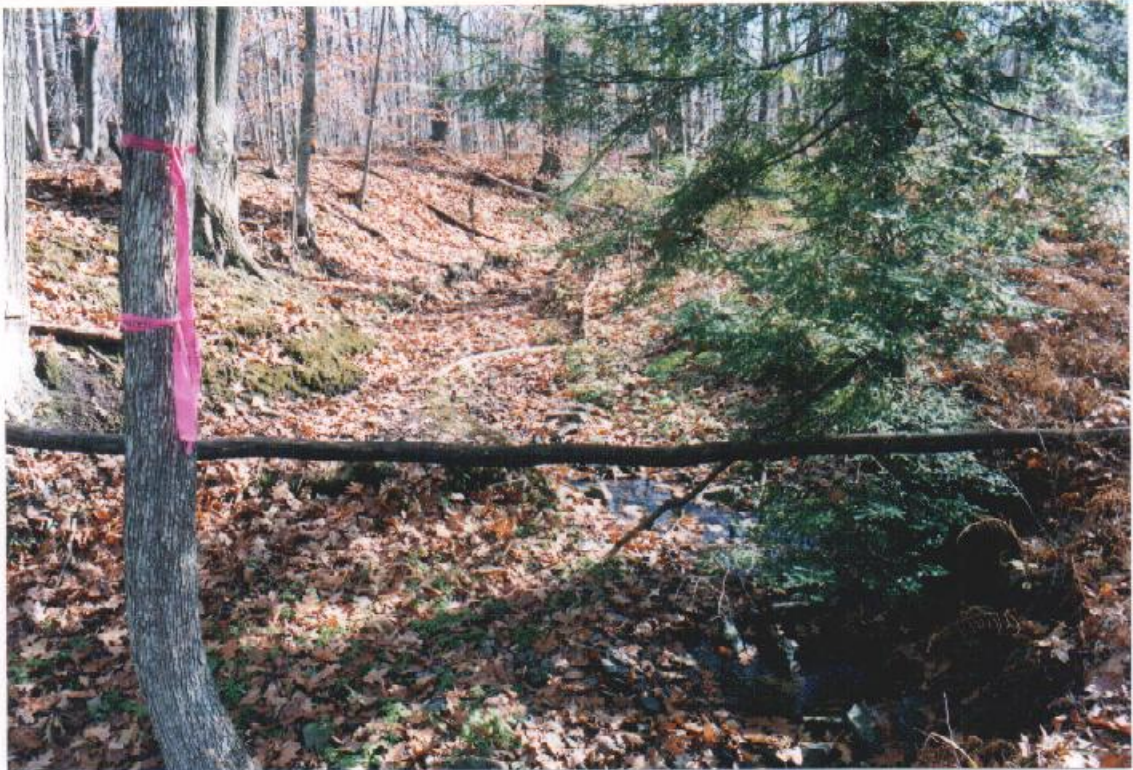
Photo 12. The upper reaches of the stream shown in Photo 12, looking upstream near flag HN-25. This part of the stream is more seepy, with wetland plants such as *Glyceria striata*, *Anthriscus sylvestris*, *Mentha X piperita*, and *Impatiens* sp. (Photographed 10/28/99.)
